Access Compliance Report Public Rights-of-Way (Curb Ramps)

Intersection ID: 3365 Main Street: CRAYTON_DR Cross Street: FAIRLEA_DR Location: NE

ADA ID: DAAAED14A423 Ramp Type: Perp Initial Pass/Fail: Fail Overall Compliance: No Severity Score: 33.75

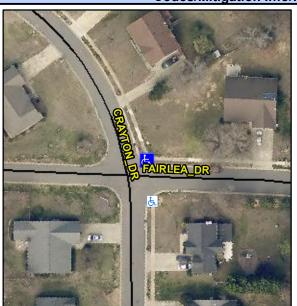
Possible Solutions:						
Remove & Replace Entire Ramp.						
· ·						
Surveyor Notes:						
N/A						
PROW/ADA:						
Not Found, R304.5.1, R304.5.3						
, ,

Comp	liance Description	Data	Comp	liance Description	Data
N/A	Ramp Length (in)	50.0	Yes	Ramp Slope (%)	5.4
No	Ramp Width (in)	45.5	No	Ramp XSlope (%)	8.1
N/A	Flare Type LT	N/A	N/A	Flare Type RT	N/A
N/A	Flare Slope LT (%)	N/A	N/A	Flare Slope RT (%)	N/A
N/A	Flare Traversable LT?	N/A	N/A	Flare Traversable RT?	N/A
N/A	Landing Length (in)	N/A	N/A	DWS Provided?	N/A
N/A	Landing Width (in)	N/A	N/A	DWS Contrast?	N/A
N/A	Landing Slope (%)	N/A	N/A	DWS Length (in)	N/A
N/A	Landing X Slope (%)	N/A	N/A	DWS Full Width?	N/A
N/A	Landing Curb? (Y/N)	N/A	N/A	DWS Offset (in)	N/A
N/A	Shared Landing?	N/A			
N/A	Gutter Ponding?	N/A	N/A	Gutter Slope (%)	N/A
N/A	Gutter Lip Ht (in)	N/A	N/A	Gutter X Slope (%)	N/A
N/A	Painted X Walk1?	No	N/A	Painted X Walk2?	N/A
	X Walk 1 Direction	To S		X Walk 2 Direction	N/A
N/A	X Walk 1 Width (in)	N/A	N/A	X Walk 2 Width (in)	N/A
	X Walk 1 Slope (%)	8.1		X Walk 2 Slope (%)	N/A
	X Walk 1 X Slope (%)	3.8		X Walk 2 X Slope (%)	N/A
