# Access Compliance Report

## Public Rights-of-Way

### (Curb Ramps)

| Intersection ID: 12316 | Main Street: ASHLEY_RD | Cross Street: GREENLAND_AV | Location: SW |

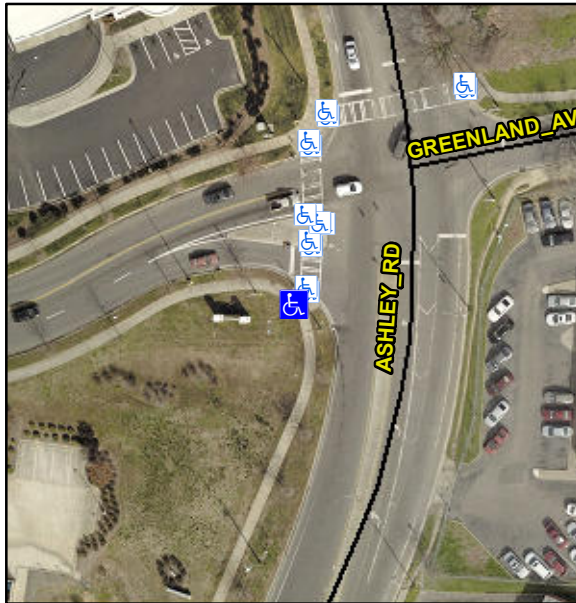
**LT RP < 5%**

**Not Found, R304.5.3, R304.2.2-Perp,  
R304.3.2-Para**

| Compliance | Description | Data | Compliance | Description | Data |
|---|---|---|---|---|---|
| No | Ramp XSlope LT (%) | 2.4 | No | Ramp XSlope RT (%) | 4.2 |
| No | Landing Slope (%) | 2.9 | Yes | DWS Length (in) | 24.0 |

**Remove & Replace Entire Ramp.  
Remove & Replace Sidewalk.**
