## **Access Compliance Report Public Rights-of-Way** (Curb Ramps)

Intersection ID: 3150 Main Street: OLD TIMBER RD **Cross Street: PROSPERITY CHURCH RD** Location: NW **ADA ID: DADF517ECCCF** Ramp Type: PerpDiag Initial Pass/Fail: Fail **Overall Compliance: No** Severity Score: 21.25

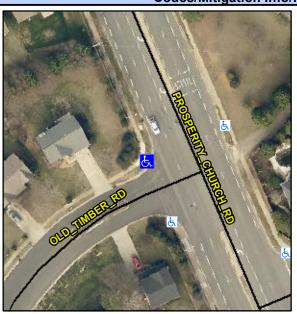
Field Measurements/Component Compliance						
Compliance Description		Data	Comp	liance	Description	Data
N/A	Ramp Length (in)	72.5	Yes	Ramp	Slope (%)	7.3
No	Ramp Width (in)	39.0	No	Ramp	XSlope (%)	6.7
N/A	Flare Type LT	N/A	N/A	Flare	Type RT	N/A
N/A	Flare Slope LT (%)	N/A	N/A	Flare	Slope RT (%)	N/A
N/A	Flare Traversable LT?	N/A	N/A	Flare	Traversable RT?	N/A
N/A	Landing Length (in)	N/A	N/A	DWS	Provided?	N/A
N/A	Landing Width (in)	N/A	N/A	DWS	Contrast?	N/A
N/A	Landing Slope (%)	N/A	N/A	DWS	Length (in)	N/A
N/A	Landing X Slope (%)	N/A	N/A	DWS	Full Width?	N/A
N/A	Landing Curb? (Y/N)	N/A	N/A	DWS	Offset (in)	N/A
N/A	Shared Landing?	N/A				
N/A	Gutter Ponding?	N/A	N/A	Gutte	r Slope (%)	N/A
N/A	Gutter Lip Ht (in)	N/A	N/A	Gutte	r X Slope (%)	N/A
N/A	Painted X Walk1?	No	N/A	Painte	ed X Walk2?	No
	X Walk 1 Direction	To S		X Wal	k 2 Direction	To E
N/A	X Walk 1 Width (in)	N/A	N/A	X Wal	k 2 Width (in)	N/A
	X Walk 1 Slope (%)	3.8		X Wal	k 2 Slope (%)	12.0

X Walk 1 X Slope (%)	10.4		X Wal	k 2 X Slope (%)	2.0
N/A	Ramp inside XWalk1?	N/A	N/A	Ramp	inside XWalk2?	N/A
	Road Slope (%)	7.3	N/A	Clear	Space?	N/A
	Road X Slope (%)	13.8	N/A	Clear	Space to XWalk (in)	N/A
N/A	Any Obstructions?	N/A	N/A	Storm	Grate/Utility Hazard?	N/A
	Obstruction Type			Storm	Grate/Utility Type	
		N/A				N/A
			Yes	Surfac	ce Condition? (G/P)	Good

Possible Solutions: **Remove & Replace Curb Ramp With Two New Directional Ramps or** Equivalent. Surveyor Notes: N/A PROW/ADA: Not Found, R304.5.1, R304.5.3
