Access Compliance Report

Public Rights-of-Way

(Curb Ramps)

Intersection ID: 7599	Main Street: LEMS福德_WY	Cross Street: WITHAM_PASSAGE	Location:	SE
ADA ID: DAF83468FDE2	Ramp Type: BlendTrans1	Initial Pass/Fail: Fail	Overall Compliance: No	Severity Score: 25
Codes/Mitigation Info/Possible Solution		Field Measurements/Component Compliance

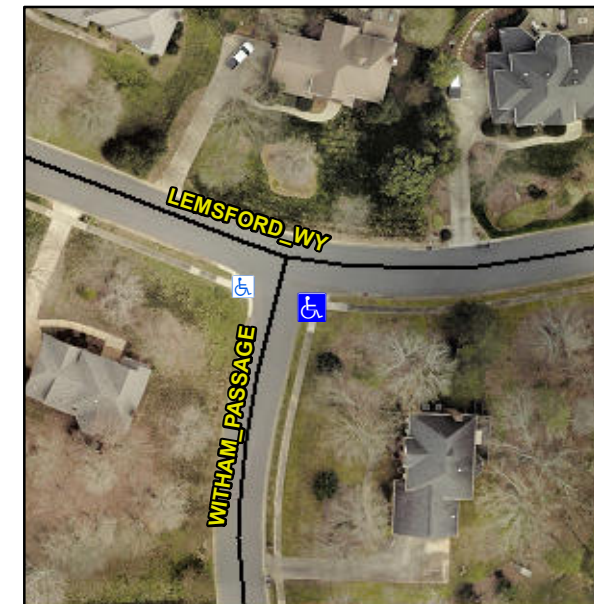
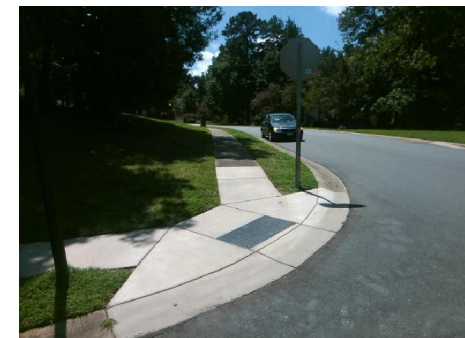
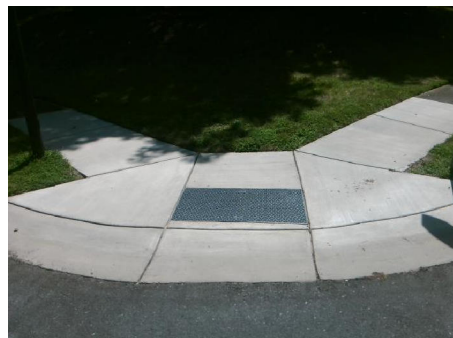
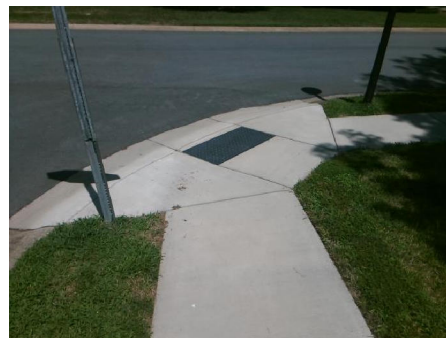
Not Found, R304.5.3

Compliance	Description	Data	Compliance	Description	Data
N/A	Ramp Length (in)	27.0	Yes	BlendTrans Slope (%)	2.9
Yes	Ramp Width (in)	48.0	No	BlendTrans XSlope (%)	8.0
N/A	Flare Type LT	N/A	N/A	Flare Type RT	N/A
N/A	Flare Slope LT (%)	N/A	N/A	Flare Slope RT (%)	N/A
N/A	Flare Traversable LT?	N/A	N/A	Flare Traversable RT?	N/A
N/A	Landing Length (in)	N/A	N/A	DWS Provided?	N/A
N/A	Landing Width (in)	N/A	N/A	DWS Contrast?	N/A
N/A	Landing Slope (%)	N/A	N/A	DWS Length (in)	N/A
N/A	Landing X Slope (%)	N/A	N/A	DWS Full Width?	N/A
N/A	Landing Curb? (Y/N)	N/A	N/A	DWS Offset (in)	N/A
N/A	Shared Landing?	N/A			
N/A	Gutter Ponding?	N/A	N/A	Gutter Slope (%)	N/A
N/A	Gutter Lip Ht (in)	N/A	N/A	Gutter X Slope (%)	N/A
N/A	Painted X Walk1?	No	N/A	Painted X Walk2?	N/A
	X Walk 1 Direction	To NW		X Walk 2 Direction	N/A
	X Walk 1 Width (in)	N/A		X Walk 2 Width (in)	N/A
	X Walk 1 Slope (%)	3.9		X Walk 2 Slope (%)	N/A
	X Walk 1 X Slope (%)	5.7		X Walk 2 X Slope (%)	N/A

N/A	Ramp inside XWalk1?	N/A	N/A	Ramp inside XWalk2?	N/A
	Road Slope (%)	5.7		Clear Space?	N/A
	Road X Slope (%)	3.9	N/A	Clear Space to XWalk (in)	N/A
N/A	Any Obstructions?	N/A	N/A	Storm Grate/Utility Hazard?	N/A
	Obstruction Type			Storm Grate/Utility Type	
		N/A			N/A
			Yes	Surface Condition? (G/P)	Good
			No	Curb Slope (%)	16.7

Remove & Replace Curb Ramp With Two New Directional Ramps or Equivalent.
