Access Compliance Report

Public Rights-of-Way

(Curb Ramps)

Intersection ID: 10147	Main Street: E_27TH_ST	Cross Street: N_TRYON_ST	Location: S
ADA ID: DB17BB40DCBA	Ramp Type: Perp	Initial Pass/Fail: Fail	Overall Compliance: No
			Severity Score: 26.25

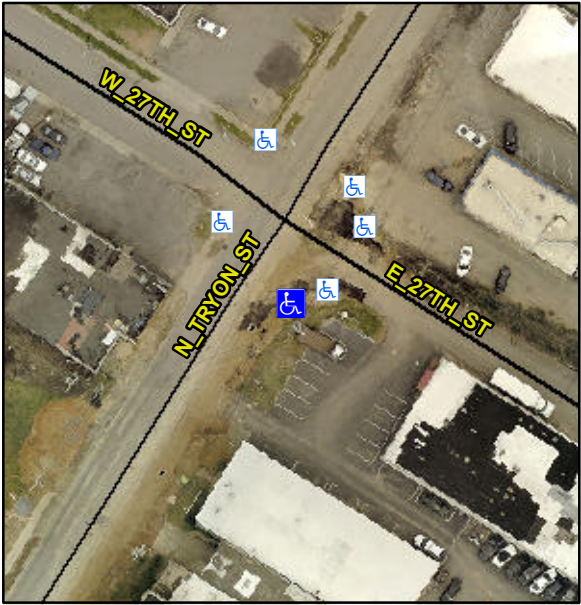
Possible Solutions:		Compliance	Description	Data
	Remove & Replace Entire Ramp.		No	Ramp Length (in)	59.0
			Yes	Ramp Width (in)	54.0
			N/A	Flare Type LT	N/A
			N/A	Flare Slope LT (%)	N/A
			N/A	Flare Traversable LT?	N/A
			N/A	Landing Length (in)	N/A
			N/A	Landing Width (in)	N/A
			N/A	Landing Slope (%)	N/A
			N/A	Landing X Slope (%)	N/A
<p>Surveyor Notes:</p> <p>N/A</p> <p>PROW/ADA:</p> <p>Not Found, R304.2.2</p>			N/A	Flare Type RT	N/A
			N/A	Flare Slope RT (%)	N/A
			N/A	Flare Traversable RT?	N/A
			N/A	DWS Provided?	N/A
			N/A	DWS Contrast?	N/A
			N/A	DWS Length (in)	N/A
			N/A	DWS Full Width?	N/A
			N/A	DWS Offset (in)	N/A
			N/A	Shared Landing?	N/A
			N/A	Gutter Ponding?	N/A
			N/A	Gutter Lip Ht (in)	N/A
			N/A	Painted X Walk1?	No
				X Walk 1 Direction	To NW
			N/A	X Walk 1 Width (in)	N/A
				X Walk 1 Slope (%)	4.4
				X Walk 1 X Slope (%)	3.0

N/A	Ramp inside XWalk1?	N/A
			N/A	Road Slope (%)	N/A
			N/A	Road X Slope (%)	N/A
			N/A	Any Obstructions?	N/A
Total Cost:		\$ 1850.00		Obstruction Type	
			N/A		
			Yes	Surface Condition? (G/P)	Good
