Access Compliance Report

Public Rights-of-Way

| Intersection ID: 10942 | Main Street: S I-77 EXIT 10B RA | Cross Street: S I-77 EXIT 10C RA | Location: N |
| ADA ID: DB1E3542F1B3 | Ramp Type: Para | Initial Pass/Fail: Fail | Overall Compliance: No |

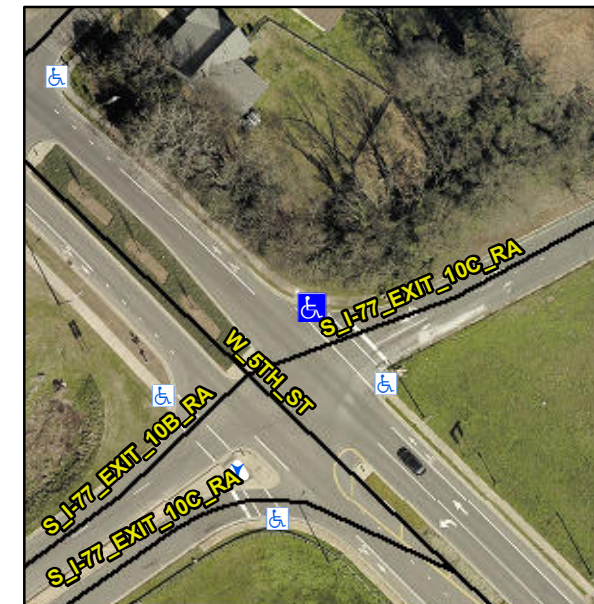
| Severity Score: 12.5 | | | |

RT RP < 5%

R304.3.2

| Compliance | Description | Data | Compliance | Description | Data |
|---|---|---|---|---|---|
| No | Ramp Slope LT (%) | 11.3 | Yes | Ramp Slope RT (%) | 1.6 |

Remove & Replace Entire Ramp.
