Access Compliance Report Public Rights-of-Way (Curb Ramps)

Intersection ID: 13541Main Street: CENTRAL_AVCross Street: EASTCREST_DRLocation:SWADA ID: DB3EE34D1524Ramp Type: PerpInitial Pass/Fail: FailOverall Compliance: NoSeverity Score: 22.5

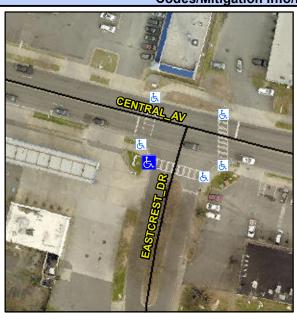
| Possible Solutions: | | | | |
|---|--|--|--|--|
| Not Found, R304.5.1, R304.2.2, | | | | |
| R304.5.3 | | | | |

| Field Measurements/Component Compliance | | | | | | | | |
|---|---|---|---|---|---|---|--|--|
| N/A | Ramp Length (in) | 59.5 | No | Ramp | Slope (%) | 8.6 | | |
| No | Ramp Width (in) | 36.5 | No Ramp XSlope (%) | | | 3.9 | | |

| Possible Solutions: | | | | |
|---|--|--|--|--|
| Remove & Replace Entire Ramp. | | | | |
