Access Compliance Report Public Rights-of-Way (Curb Ramps)

Intersection ID: 48374 Main Street: REDBUD ST **Cross Street: TATE_ST** Location: NW **Severity Score: Overall Compliance: No** ADA ID: DB687627D531 Ramp Type: Para Initial Pass/Fail: Fail 22.5

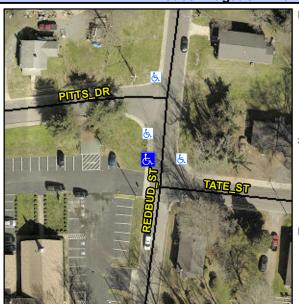
Possible Solutions:	9
Remove & Replace Entire Ramp.	ı
·	١
	1
	1
	1
	ı
Surveyor Notes:	ı
RT RP < 5%	N
	ı
	N
	N
PROW/ADA:	N
R304.5.1, R304.3.2, R304.5.3	N
	ŀ
	N

Field Measurements/Component Compliance							
Comp	liance Description	Data	Comp	liance Description	Data		
N/A	Ramp Length LT (in)	70.0	N/A	Ramp Length RT (in)	74.0		
Yes	Ramp Width LT (in)	48.0	No	Ramp Width RT (in)	47.0		
No	Ramp Slope LT (%)	9.4	Yes	Ramp Slope RT (%)	3.7		
No	Ramp XSlope LT (%)	2.2	No	Ramp XSlope RT (%)	2.3		
N/A	Landing Length (in)	N/A	N/A	DWS Provided?	N/A		
N/A	Landing Width (in)	N/A	N/A	DWS Contrast?	N/A		
N/A	Landing Slope (%)	N/A	N/A	DWS Length (in)	N/A		
N/A	Landing X Slope (%)	N/A	N/A	DWS Full Width?	N/A		
N/A	Landing Curb? (Y/N)	N/A	N/A	DWS Offset (in)	N/A		
N/A	Shared Landing?	N/A					
N/A	Gutter Ponding?	N/A	N/A	Gutter Slope (%)	N/A		
N/A	Gutter Lip Ht (in)	N/A	N/A	Gutter X Slope (%)	N/A		
N/A	Painted X Walk1?	No	N/A	Painted X Walk2?	N/A		
	X Walk 1 Direction	To E		X Walk 2 Direction	N/A		
N/A	X Walk 1 Width (in)	N/A	N/A	X Walk 2 Width (in)	N/A		
	X Walk 1 Slope (%)	7.2		X Walk 2 Slope (%)	N/A

X Walk 1 X Slope (%)	2.9		X Walk 2 X Slope (%)	N/A		
N/A	Ramp inside XWalk1?	N/A	N/A	Ramp inside XWalk2?	N/A		
	Road Slope (%)	N/A	N/A	Clear Space?	N/A		
	Road X Slope (%)	N/A	N/A	Clear Space to XWalk (in)	N/A		
N/A	Any Obstructions?	N/A	N/A	Storm Grate/Utility Hazard?	N/A		
	Obstruction Type			Storm Grate/Utility Type			
		N/A			N/A		
			Yes	Surface Condition? (G/P)	Good		
			N/A	Curb Slope (%)	13.0
