Access Compliance Report Public Rights-of-Way (Curb Ramps)

Intersection ID: 14326 Main Street: BALDWIN_AV Cross Street: LUTHER_ST Location: E

ADA ID: DB6EA1EBB08E Ramp Type: PerpDiag Initial Pass/Fail: Fail Overall Compliance: No Severity Score: 35

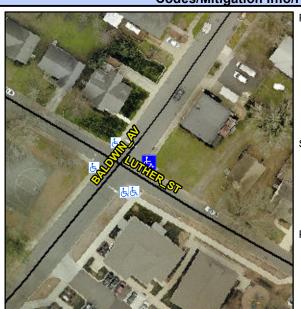
R304.5.1, R304.2.2, R304.5.3

Field Measurements/Component Compliance							
	Compliance Description		Data	Compli	ance	Description	Data
	N/A	Ramp Length (in)	60.0	No	Ramp	Slope (%)	13.3
	No	Ramp Width (in)	40.0	No	Ramp XSlope (%)		4.7
	N/A	Flare Type LT	N/A	N/A	Flare Type RT		N/A
	N/A	Flare Slope LT (%)	N/A	N/A	Flare Slope RT (%)		N/A
	N/A	Flare Traversable LT?	N/A	N/A	Flare	Traversable RT?	N/A
	N/A	Landing Length (in)	N/A	N/A	DWS	Provided?	N/A
	N/A	Landing Width (in)	N/A	N/A	DWS	Contrast?	N/A
	N/A	Landing Slope (%)	N/A	N/A	DWS	Length (in)	N/A
	N/A	Landing X Slope (%)	N/A	N/A	DWS	Full Width?	N/A
	N/A	Landing Curb? (Y/N)	N/A	N/A	DWS	Offset (in)	N/A
	N/A	Shared Landing?	N/A				
	N/A	Gutter Ponding?	Yes	N/A	Gutte	r Slope (%)	N/A
	N/A	Gutter Lip Ht (in)	N/A	N/A	Gutte	r X Slope (%)	N/A
	N/A	Painted X Walk1?	No	N/A	Paint	ed X Walk2?	No
		X Walk 1 Direction	To NW		X Wa	lk 2 Direction	To SW
	N/A	X Walk 1 Width (in)	N/A	N/A	X Wa	lk 2 Width (in)	N/A

Remove & Replace Curb Ramp With Two New Directional Ramps or Equivalent.
