# Access Compliance Report

## Public Rights-of-Way

### (Curb Ramps)

| Intersection ID: 45644 | Main Street: W_5TH_ST | Cross Street: W_6TH_ST | Location: NE |

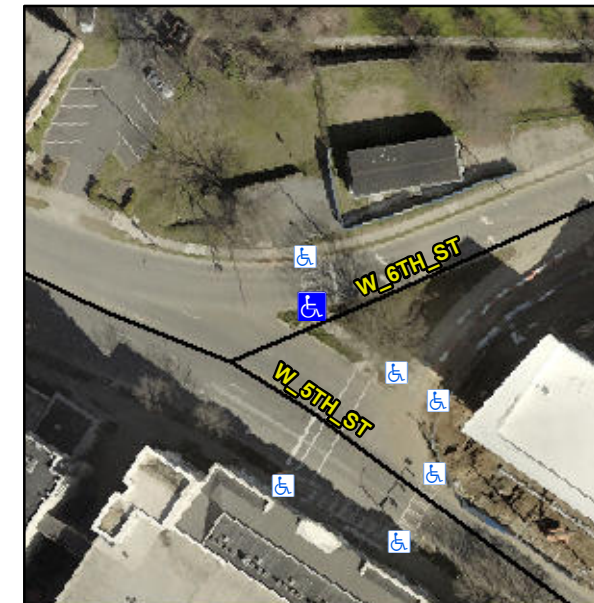
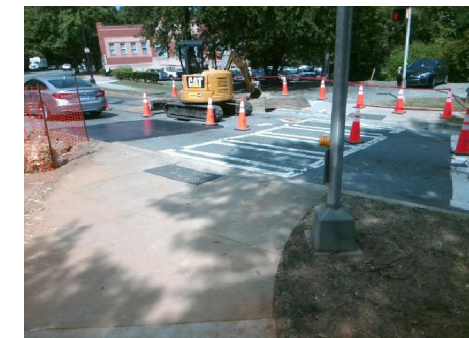
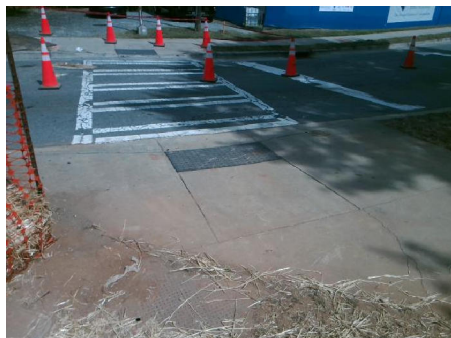
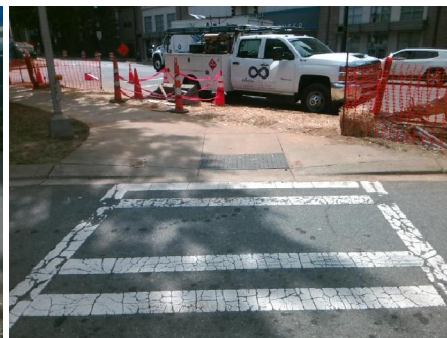
**Not Found, R304.2.2**

| Compliance | Description | Data | Compliance | Description | Data |
|---|---|---|---|---|---|
| N/A | Ramp Length (in) | 72.0 | No | Ramp Slope (%) | 9.6 |

**Remove & Replace Entire Ramp.**
