# Access Compliance Report

## Public Rights-of-Way

| Intersection ID: 10393 | Main Street: LIMA_AV | Cross Street: ROZZELLES_FERRY_RD | Location: | N |
| ADA ID: DBCB2FE9F3B7 | Ramp Type: Combination1Diag | Initial Pass/Fail: Fail | Overall Compliance: No | Severity Score: 0 |

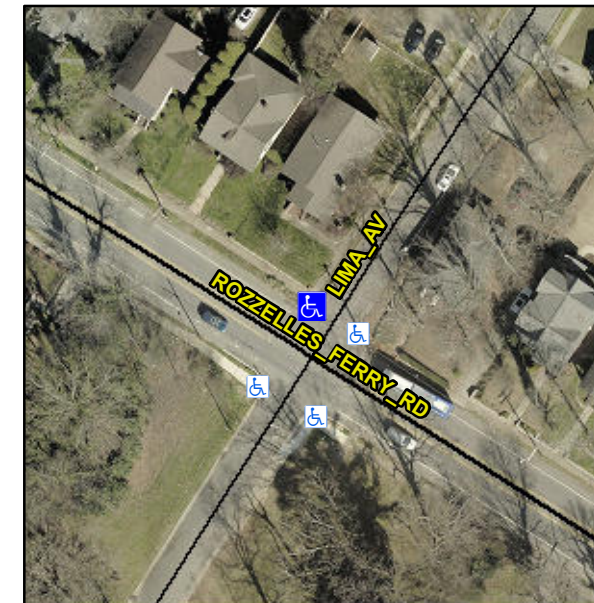
**LT RP < 5%**

**Not Found, R304.5.1, R304.5.1, R304.2.2, R304.5.3, R304.3.2**

| Compliance | Description | Data | Compliance | Description | Data |
|---|---|---|---|---|---|
| Yes | Ramp Width LT (in) | 59.0 | No | Ramp Width RT (in) | 42.0 |
| Yes | Ramp Slope LT (%) | 2.1 | No | Ramp Slope RT (%) | 18.2 |
| No | Ramp XSlope LT (%) | 9.0 | Yes | Ramp XSlope RT (%) | 1.2 |
| N/A | Ramp Length (in) | 47.0 | No | Ramp Slope (%) | 10.5 |
| No | Ramp Width (in) | 29.0 | No | Ramp XSlope (%) | 10.6 |

**Remove & Replace Curb Ramp With Two New Directional Ramps or Equivalent.**
