# Access Compliance Report

## Public Rights-of-Way

### (Curb Ramps)

Intersection ID: 43365	Main Street: EASTFIELD_RD	Cross Street: SIMONTON_DR	Location: S
ADA ID: DBCE081DCAB9	Ramp Type: Perp	Initial Pass/Fail: Fail	Overall Compliance: No
			Severity Score: 13.75

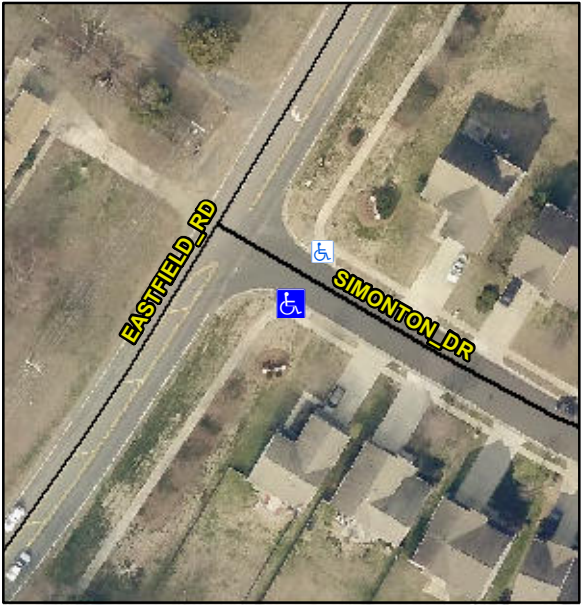
Possible Solutions:		<b>Compliance</b>	<b>Description</b>	<b>Data</b>
	<b>Remove &amp; Replace Entire Ramp.</b>		<b>No</b>	Ramp Length (in)	<b>50.0</b>
			<b>Yes</b>	Ramp Width (in)	<b>48.0</b>
			<b>N/A</b>	Flare Type LT	<b>N/A</b>
			<b>N/A</b>	Flare Slope LT (%)	<b>N/A</b>
			<b>N/A</b>	Flare Traversable LT?	<b>N/A</b>
			<b>N/A</b>	Landing Length (in)	<b>N/A</b>
			<b>N/A</b>	Landing Width (in)	<b>N/A</b>
			<b>N/A</b>	Landing Slope (%)	<b>N/A</b>
			<b>N/A</b>	Landing X Slope (%)	<b>N/A</b>
<p>Surveyor Notes:</p> <p><b>N/A</b></p> <p>PROW/ADA:</p> <p><b>Not Found, R304.2.2, R304.5.3</b></p>			<b>N/A</b>	Flare Type RT	<b>N/A</b>
			<b>N/A</b>	Flare Slope RT (%)	<b>N/A</b>
			<b>N/A</b>	Flare Traversable RT?	<b>N/A</b>
			<b>N/A</b>	DWS Provided?	<b>N/A</b>
			<b>N/A</b>	DWS Contrast?	<b>N/A</b>
			<b>N/A</b>	DWS Length (in)	<b>N/A</b>
