Access Compliance Report

Public Rights-of-Way

(Curb Ramps)

Intersection ID: 8896	Main Street: LISA_CAROLE_DR	Cross Street: STONE_BLUFF_CT	Location: S
ADA ID: DCF4D151E1A8	Ramp Type: Perp	Initial Pass/Fail: Fail	Overall Compliance: No
		Severity Score: 8.75

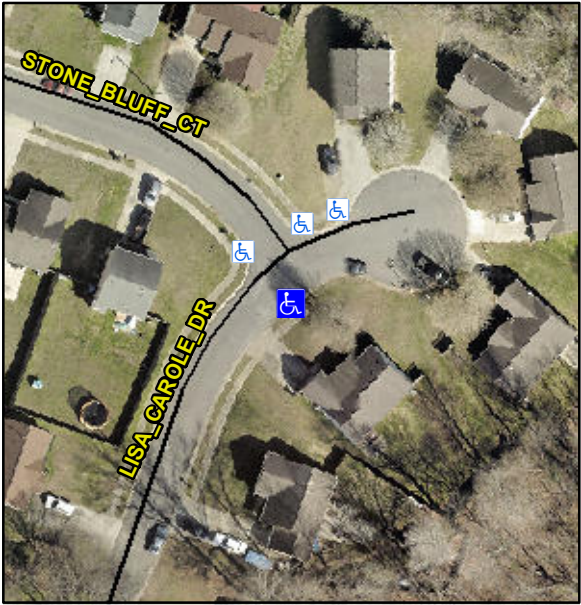
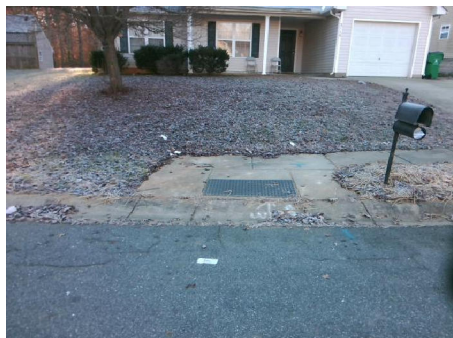
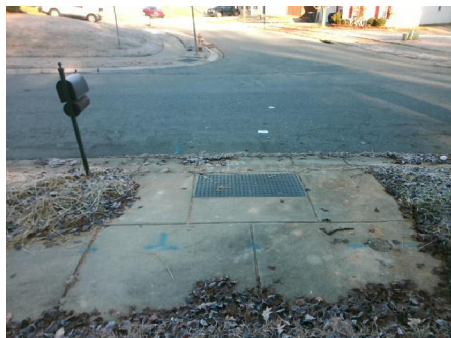
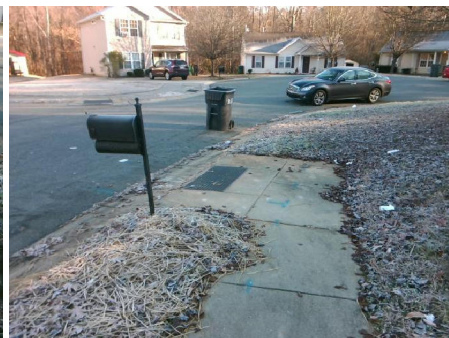
4.5	X Walk 1 Slope (%)	N/A
			1.9	X Walk 1 X Slope (%)	N/A
			N/A	Ramp inside XWalk1?	N/A
<p>Surveyor Notes:</p> <p>N/A</p> <p>PROW/ADA:</p> <p>Not Found, R304.5.1</p> <p>Total Cost: \$ 1850.00</p>			N/A	Ramp inside XWalk2?	N/A
			N/A	Road Slope (%)	N/A
			N/A	Road X Slope (%)	N/A
			N/A	Any Obstructions?	N/A
				Obstruction Type	
			N/A		N/A
			Yes	Surface Condition? (G/P)	Good

<p>Street 1 Name LISA CAROLE DR</p> <p>Stop Condition-Street 2 None</p> <p>Street 2 Name N/A</p> <p>Stop Condition-Street 1 N/A</p>	Possible Solutions:		Compliance	Description	Data
	Remove & Replace Entire Ramp.		Yes	Ramp Slope (%)	6.6
			No	Ramp Width (in)	1.2
			N/A	Flare Type LT	N/A
			N/A	Flare Slope LT (%)	N/A
			N/A	Flare Traversable LT?	N/A
			N/A	Landing Length (in)	N/A
			N/A	Landing Width (in)	N/A
			N/A	Landing Slope (%)	N/A
			N/A	Landing X Slope (%)	N/A
			N/A	Landing Curb? (Y/N)	N/A
			N/A	Shared Landing?	N/A
			N/A	Gutter Ponding?	N/A
			N/A	Gutter Lip Ht (in)	N/A
			No	Painted X Walk1?	N/A
			To NW	X Walk 1 Direction	N/A
			N/A	X Walk 1 Width (in)	N/A
