Intersection ID: 10996	Main Street: E_24TH_ST	Cross Street: N_DAVIDSON_ST	Location:	W
ADA ID: DD3D426443A5	Ramp Type: BlendTrans1	Initial Pass/Fail: Fail	Overall Compliance: No	Severity Score: 33.75

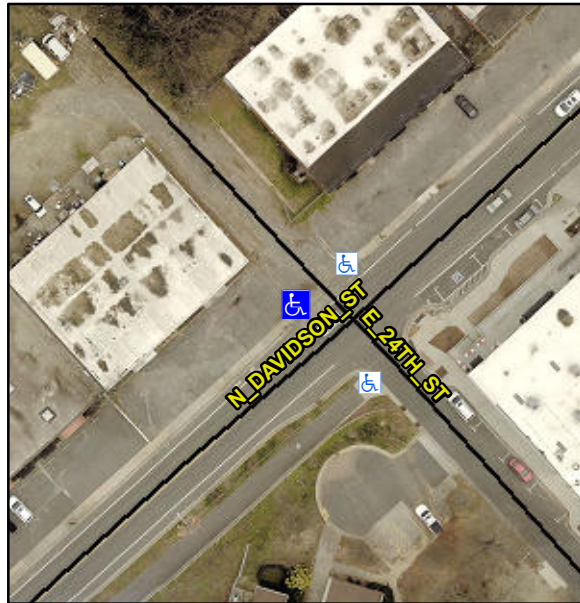
POWER POLE OBS 40.0

Not Found, R304.5.1, R304.5.3

Remove & Replace Curb Ramp With Two New Directional Ramps or Equivalent.

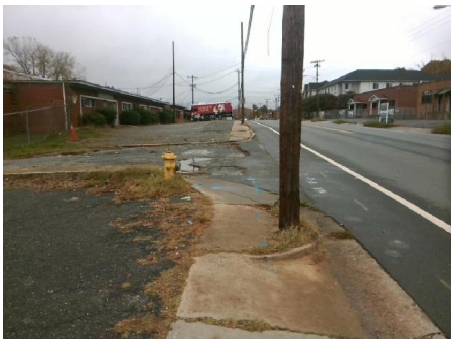
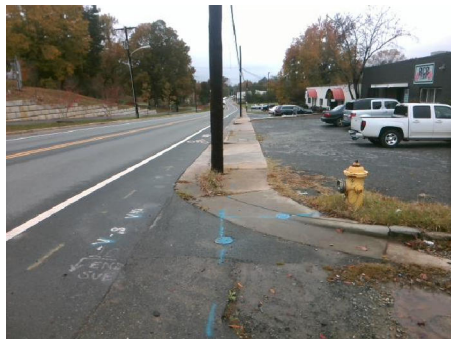
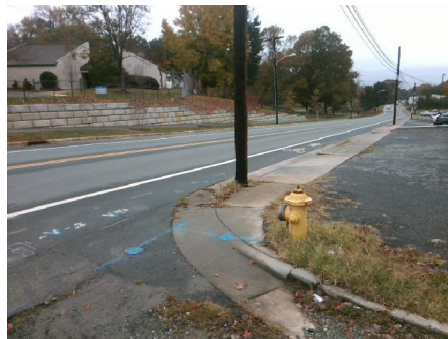
Possible Solutions:			Compliance	Description	Data	Compliance	Description	Data
Remove & Replace Curb Ramp With Two New Directional Ramps or Equivalent.	N/A	Ramp Length (in)	92.0	Yes	BlendTrans Slope (%)	0.4		
	No	Ramp Width (in)	40.0	No	BlendTrans XSlope (%)	7.9		
	N/A	Flare Type LT	N/A	N/A	Flare Type RT	N/A		
	N/A	Flare Slope LT (%)	N/A	N/A	Flare Slope RT (%)	N/A		
	N/A	Flare Traversable LT?	N/A	N/A	Flare Traversable RT?	N/A		
	N/A	Landing Length (in)	N/A	N/A	DWS Provided?	N/A		
	N/A	Landing Width (in)	N/A	N/A	DWS Contrast?	N/A		
	N/A	Landing Slope (%)	N/A	N/A	DWS Length (in)	N/A		
	N/A	Landing X Slope (%)	N/A	N/A	DWS Full Width?	N/A		
	N/A	Landing Curb? (Y/N)	N/A	N/A	DWS Offset (in)	N/A		
Surveyor Notes: POWER POLE OBS 40.0	N/A	Shared Landing?	N/A					
	N/A	Gutter Ponding?	N/A	N/A	Gutter Slope (%)	N/A		
	N/A	Gutter Lip Ht (in)	N/A	N/A	Gutter X Slope (%)	N/A		
	N/A	Painted X Walk1?	No	N/A	Painted X Walk2?	N/A

X Walk 1 Direction	To NE		X Walk 2 Direction	N/A		
		X Walk 1 Width (in)	N/A		X Walk 2 Width (in)	N/A		
		X Walk 1 Slope (%)	3.9		X Walk 2 Slope (%)	N/A		
		X Walk 1 X Slope (%)	0.3		X Walk 2 X Slope (%)	N/A		
	N/A	Ramp inside XWalk1?	N/A	N/A	Ramp inside XWalk2?	N/A		
		Road Slope (%)	0.3		Clear Space?	N/A		
PROW/ADA: Not Found, R304.5.1, R304.5.3		Road X Slope (%)	3.9	N/A	Clear Space to XWalk (in)	N/A		
	N/A	Any Obstructions?	Yes	N/A	Storm Grate/Utility Hazard?	N/A		
		Obstruction Type			Storm Grate/Utility Type			
	POWER POLE 40.0					N/A		
				Yes	Surface Condition? (G/P)	Good		
				No	Curb Slope (%)	5.3		
	Total Cost:	\$	3200.00
