Access Compliance Report

Public Rights-of-Way

(Curb Ramps)

Intersection ID: 14006	Main Street: ELIZABETH_AV	Cross Street: HAWTHORNE_LN	Location:	W
ADA ID: DE731BABF1F1	Ramp Type: Combination1	Initial Pass/Fail: Fail	Overall Compliance: No	Severity Score: 22.5

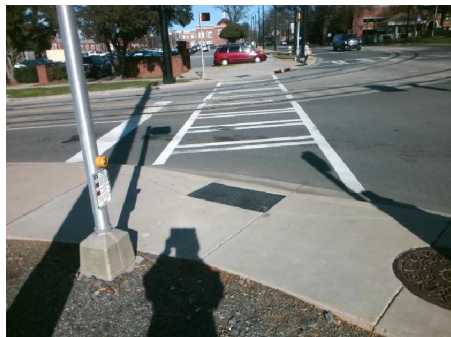
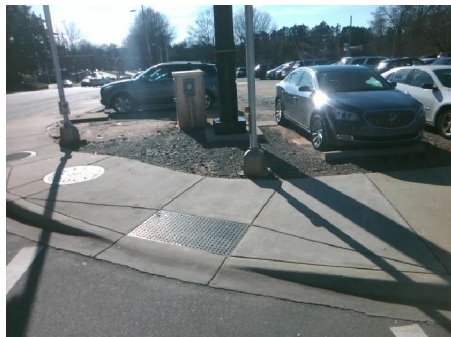
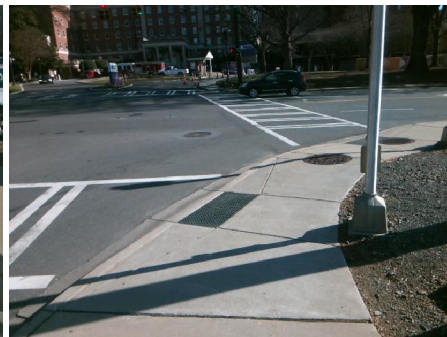
RT RP < 5%

R304.5.1, R304.3.2, R304.5.3

Compliance	Description	Data	Compliance	Description	Data
N/A	Ramp Length LT (in)	60.0	N/A	Ramp Length RT (in)	47.0
No	Ramp Width LT (in)	47.0	Yes	Ramp Width RT (in)	58.0
No	Ramp Slope LT (%)	9.8	Yes	Ramp Slope RT (%)	3.3
No	Ramp XSlope LT (%)	3.3	Yes	Ramp XSlope RT (%)	1.9
N/A	Ramp Length (in)	24.5	Yes	Ramp Slope (%)	5.1
Yes	Ramp Width (in)	48.0	Yes	Ramp XSlope (%)	2.2
N/A	Flare Type LT	N/A	N/A	Flare Type RT	N/A
N/A	Flare Slope LT (%)	N/A	N/A	Flare Slope RT (%)	N/A
N/A	Flare Traversable LT?	N/A	N/A	Flare Traversable RT?	N/A
N/A	Landing Length (in)	N/A	N/A	DWS Provided?	N/A
N/A	Landing Width (in)	N/A	N/A	DWS Contrast?	N/A
N/A	Landing Slope (%)	N/A	N/A	DWS Length (in)	N/A
N/A	Landing X Slope (%)	N/A	N/A	DWS Full Width?	N/A
N/A	Landing Curb? (Y/N)	N/A	N/A	DWS Offset (in)	N/A
N/A	Shared Landing?	N/A			
N/A	Gutter Ponding?	N/A	N/A	Gutter Slope (%)	N/A
N/A	Gutter Lip Ht (in)	N/A	N/A	Gutter X Slope (%)	N/A
N/A	Painted X Walk1?	Yes	N/A	Painted X Walk2?	N/A

Remove & Replace Entire Ramp.
