# Access Compliance Report

## Public Rights-of-Way

| Intersection ID: 23663 | Main Street: S_TRYON_ST | Cross Street: ERWIN_RD | Location: SE |
| ADA ID: DE74335AD005 | Ramp Type: Combination1 | Initial Pass/Fail: Pass | Overall Compliance: No |

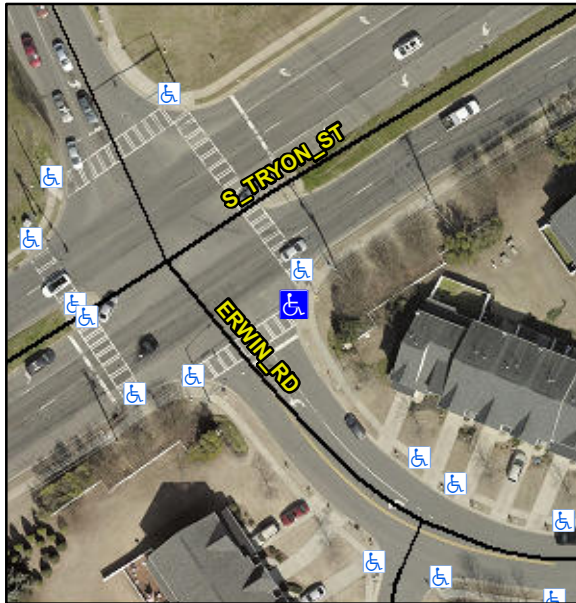
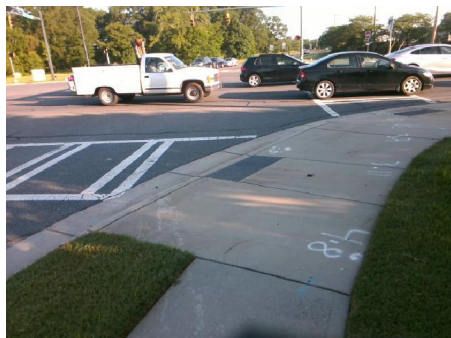
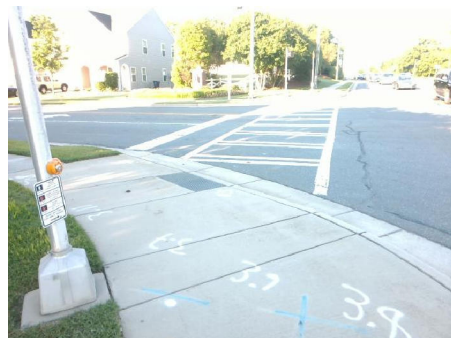
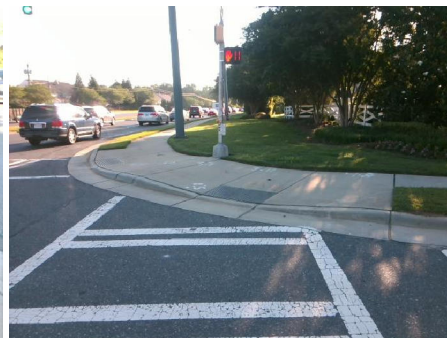
**RT RP < 5%**

**Not Found, R304.5.3, R304.2.2-Perp,  
R304.3.2-Para, R302.7.2**

| Compliance | Description | Data | Compliance | Description | Data |
|---|---|---|---|---|---|
| No | Ramp XSlope LT (%) | 3.9 | No | Ramp XSlope RT (%) | 2.7 |
| No | Landing Slope (%) | 3.7 | Yes | DWS Length (in) | 24.5 |
| No | Landing X Slope (%) | 2.1 | Yes | DWS Full Width? | Yes |
| No | Gutter Lip Ht (in) | 1.0 | Yes | Gutter X Slope (%) | 1.2 |

**Remove & Replace Entire Ramp.  
Remove & Replace Sidewalk.**
