# Access Compliance Report

## Public Rights-of-Way

### (Curb Ramps)

| Intersection ID: 7293 | Main Street: ECHO_GLEN_RD | Cross Street: TOM_HUNTER_RD | Location: SE |

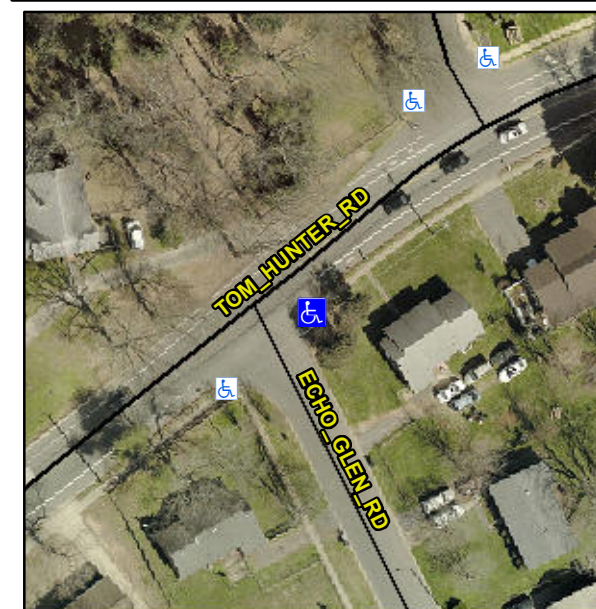
| ADA ID: DEC32E486DE5 | Ramp Type: Perp | Initial Pass/Fail: Fail | Overall Compliance: No |
| Codes/Mitigation Info/Possible Solution | | | Severity Score: 10 |

**Not Found, R304.5.1, R304.5.3**

| Compliance | Description | Data | Compliance | Description | Data |
|---|---|---|---|---|---|
| No | Ramp Width (in) | 40.5 | No | Ramp XSlope (%) | 3.3 |

**Remove & Replace Entire Ramp.**
