Access Compliance Report

Public Rights-of-Way

(Curb Ramps)

Intersection ID: 45437	Main Street: HENDERSON_CR	Cross Street: LABORDE_AV	Location: NW
ADA ID: DEF57081B192	Ramp Type: Perp	Initial Pass/Fail: Fail	Overall Compliance: No
Codes/Mitigation Info/Possible Solution			Severity Score: 60
			Field Measurements/Component Compliance

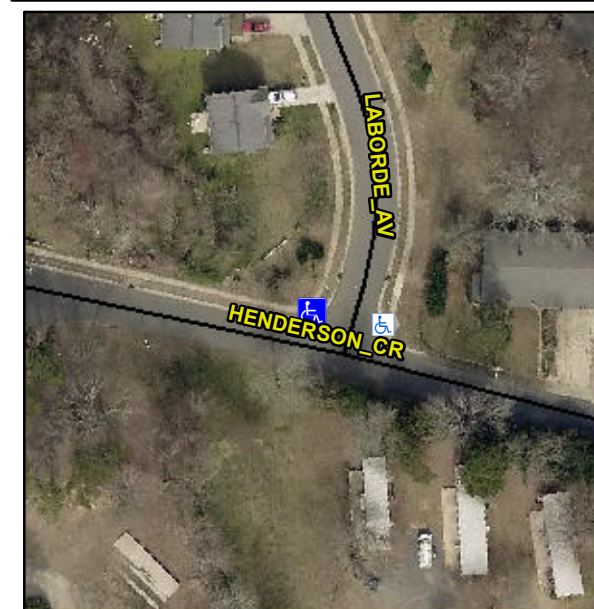
Not Found, R304.5.1, R304.2.2

Compliance	Description	Data	Compliance	Description	Data
N/A	Ramp Length (in)	49.5	No	Ramp Slope (%)	15.7
No	Ramp Width (in)	30.0	Yes	Ramp XSlope (%)	1.5
N/A	Flare Type LT	N/A	N/A	Flare Type RT	N/A
N/A	Flare Slope LT (%)	N/A	N/A	Flare Slope RT (%)	N/A
N/A	Flare Traversable LT?	N/A	N/A	Flare Traversable RT?	N/A
N/A	Landing Length (in)	N/A	N/A	DWS Provided?	N/A
N/A	Landing Width (in)	N/A	N/A	DWS Contrast?	N/A
N/A	Landing Slope (%)	N/A	N/A	DWS Length (in)	N/A
N/A	Landing X Slope (%)	N/A	N/A	DWS Full Width?	N/A
N/A	Landing Curb? (Y/N)	N/A	N/A	DWS Offset (in)	N/A
N/A	Shared Landing?	N/A			
N/A	Gutter Ponding?	N/A	N/A	Gutter Slope (%)	N/A
N/A	Gutter Lip Ht (in)	N/A	N/A	Gutter X Slope (%)	N/A
N/A	Painted X Walk1?	No	N/A	Painted X Walk2?	N/A
	X Walk 1 Direction	To SE		X Walk 2 Direction	N/A
N/A	X Walk 1 Width (in)	N/A	N/A	X Walk 2 Width (in)	N/A
	X Walk 1 Slope (%)	4.3		X Walk 2 Slope (%)	N/A
	X Walk 1 X Slope (%)	0.1		X Walk 2 X Slope (%)	N/A

Remove & Replace Entire Ramp.
