Access Compliance Report Public Rights-of-Way (Curb Ramps)

Intersection ID: 47277Main Street: CANDLEWOOD_RIDGE_LNCross Street: CARRINGTON_FOREST_LNLocation:SEADA ID: DF32787B3B76Ramp Type: BlendTrans1Initial Pass/Fail: FailOverall Compliance: NoSeverity Score:10

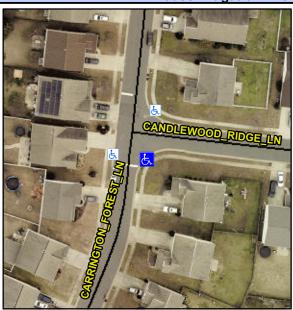
Not Found, R304.5.1, R304.5.3

Field Measurements/Component Compliance					
Compliance Description		Data	Compliance Description		Data
N/A	Ramp Length (in)	48.5	Yes	BlendTrans Slope (%)	4.2
No	Ramp Width (in)	39.5	No	BlendTrans XSlope (%)	2.2
N/A	Flare Type LT	N/A	N/A	Flare Type RT	N/A
N/A	Flare Slope LT (%)	N/A	N/A	Flare Slope RT (%)	N/A
N/A	Flare Traversable LT?	N/A	N/A	Flare Traversable RT?	N/A
N/A	Landing Length (in)	N/A	N/A	DWS Provided?	N/A
N/A	Landing Width (in)	N/A	N/A	DWS Contrast?	N/A
N/A	Landing Slope (%)	N/A	N/A	DWS Length (in)	N/A
N/A	Landing X Slope (%)	N/A	N/A	DWS Full Width?	N/A
N/A	Landing Curb? (Y/N)	N/A	N/A	DWS Offset (in)	N/A
N/A	Shared Landing?	N/A			
N/A	Gutter Ponding?	N/A	N/A	Gutter Slope (%)	N/A
N/A	Gutter Lip Ht (in)	N/A	N/A	Gutter X Slope (%)	N/A
N/A	Painted X Walk1?	No	N/A	Painted X Walk2?	No
	X Walk 1 Direction	To N		X Walk 2 Direction	To W
	X Walk 1 Width (in)	N/A		X Walk 2 Width (in)	N/A
	X Walk 1 Slope (%)	4.1		X Walk 2 Slope (%)	3.3

X Walk 1 X Slope (%)	3.8		X Walk 2 X Slope (%)	1.6
N/A	Ramp inside XWalk1?	N/A	N/A	Ramp inside XWalk2?	N/A
	Road Slope (%)	3.3		Clear Space?	N/A
	Road X Slope (%)	4.3	N/A	Clear Space to XWalk (in)	N/A
N/A	Any Obstructions?	N/A	N/A	Storm Grate/Utility Hazard?	N/A
	Obstruction Type			Storm Grate/Utility Type	
		N/A			N/A
			Yes	Surface Condition? (G/P)	Good
	\ \fi \ \f		No	Curb Slope (%)	7.5

Remove & Replace Curb Ramp With Two New Directional Ramps or Equivalent.
