Access Compliance Report Public Rights-of-Way (Curb Ramps)

Intersection ID: 3555Main Street:SAXONBURY_WYCross Street:WINDY_MEADOW_LNLocation:SEADA ID: DF44EB39CC60Ramp Type:PerpInitial Pass/Fail:FailOverall Compliance:NoSeverity Score:25

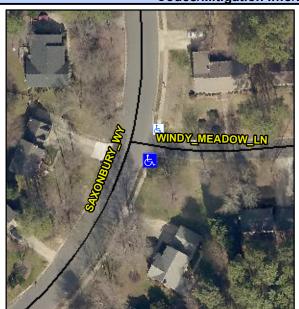
Not Found, R304.5.3

Field Measurements/Component Compliance							
Compli		iance Description	Data	Compliance		Description	Data
	N/A	Ramp Length (in)	50.0	Yes	Ramp	Slope (%)	5.0
	Yes	Ramp Width (in)	48.5	No	Ramp	XSlope (%)	7.7
	N/A	Flare Type LT	N/A	N/A	Flare	Type RT	N/A
	N/A	Flare Slope LT (%)	N/A	N/A	Flare	Slope RT (%)	N/A
	N/A	Flare Traversable LT?	N/A	N/A	Flare	Traversable RT?	N/A
	N/A	Landing Length (in)	N/A	N/A	DWS	Provided?	N/A
	N/A	Landing Width (in)	N/A	N/A	DWS	Contrast?	N/A
	N/A	Landing Slope (%)	N/A	N/A	DWS	Length (in)	N/A
	N/A	Landing X Slope (%)	N/A	N/A	DWS	Full Width?	N/A
	N/A	Landing Curb? (Y/N)	N/A	N/A	DWS	Offset (in)	N/A
	N/A	Shared Landing?	N/A				
	N/A	Gutter Ponding?	N/A	N/A	Gutte	er Slope (%)	N/A
	N/A	Gutter Lip Ht (in)	N/A	N/A	Gutte	er X Slope (%)	N/A
	N/A	Painted X Walk1?	No	N/A	Paint	ed X Walk2?	N/A
		X Walk 1 Direction	To N		X Wa	lk 2 Direction	N/A
	N/A	X Walk 1 Width (in)	N/A	N/A	X Wa	lk 2 Width (in)	N/A

X Walk 1 Slope (%)	10.5		X Wa	lk 2 Slope (%)	N/A
		X Walk 1 X Slope (%)	2.0		X Wa	lk 2 X Slope (%)	N/A
	N/A	Ramp inside XWalk1?	N/A	N/A	Ramp	inside XWalk2?	N/A
		Road Slope (%)	N/A	N/A	Clear	Space?	N/A
		Road X Slope (%)	N/A	N/A	Clear	Space to XWalk (in)	N/A
	N/A	Any Obstructions?	N/A	N/A	Storm	n Grate/Utility Hazard?	N/A
		Obstruction Type			Storm	n Grate/Utility Type	
			N/A				N/A
				Yes	Surfa	ce Condition? (G/P)	Good

Remove & Replace Entire Ramp.
