# Access Compliance Report

## Public Rights-of-Way

| Intersection ID: N/A | Main Street: DELUCA_DR | Cross Street: GALVIN_ST | Location: SE |
| ADA ID: DF797412DAEA | Ramp Type: Combination2Diag | Initial Pass/Fail: Pass | Overall Compliance: No |

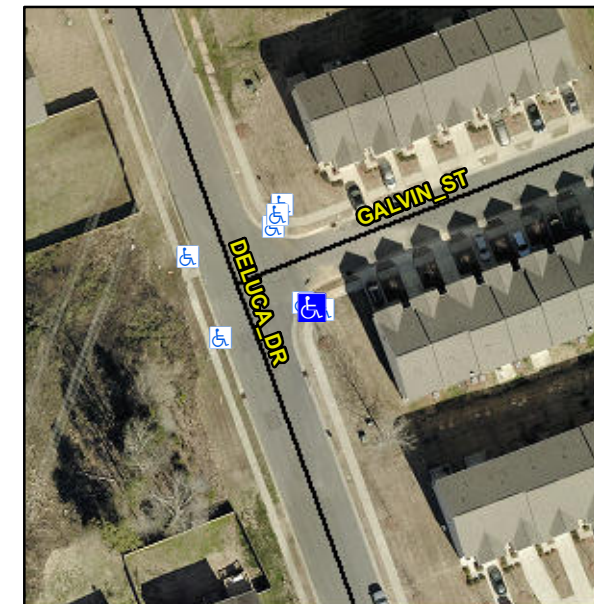
**Not Found, R304.5.3, R304.2.1, R304.2.2-Perp, R304.3.2-Para, R305.1.4, R302.7.2, R304.5.4**

**Remove & Replace Curb Ramp With Two New Directional Ramps or Equivalent. Remove & Replace Gutter.**
