Access Compliance Report

Public Rights-of-Way

| Intersection ID: 7375 | Main Street: N_TRYON_ST | Cross Street: TOM_HUNTER_RD | Location: NW |
| ADA ID: DF7B0893F8C8 | Ramp Type: MedianPerp | Initial Pass/Fail: Fail | Overall Compliance: No |

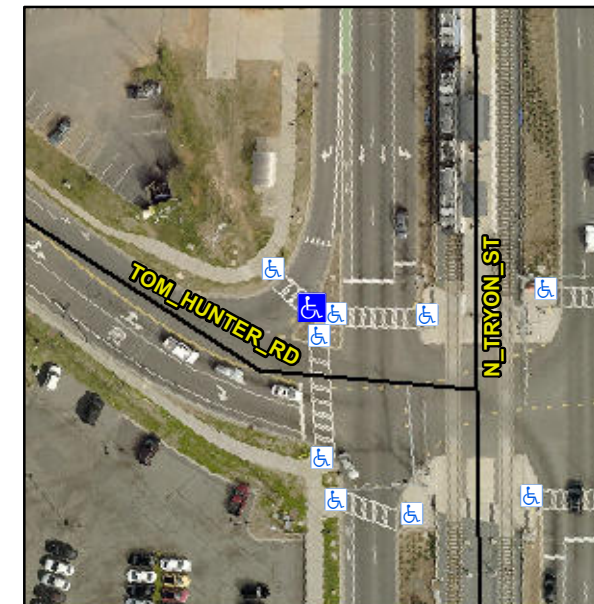
| Severity Score: 1.25 | | | |

Not Found, R304.5.3

| Compliance | Description | Data | Compliance | Description | Data |
|---|---|---|---|---|---|
| Yes | Ramp Width (in) | 92.0 | No | Ramp XSlope (%) | 3.5 |

Possible Solutions:

Remove & Replace Entire Ramp.

Total Cost: \$ 1650.00
