Access Compliance Report

Public Rights-of-Way

(Curb Ramps)

Intersection ID: 28497	Main Street: BROOKMERE_LN	Cross Street: NORTHWOODS_FOREST_DR	Location: SW
ADA ID: DF8C397450DB	Ramp Type: Combination1	Initial Pass/Fail: Fail	Overall Compliance: No
			Severity Score: 18.75

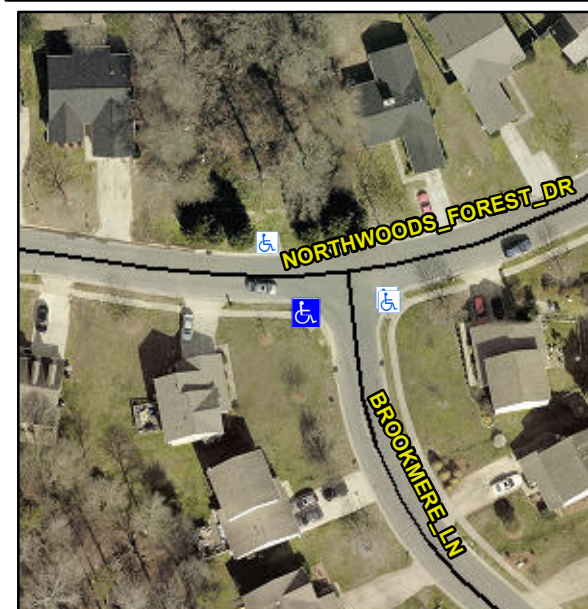
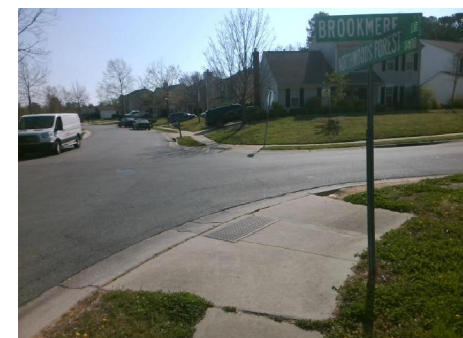
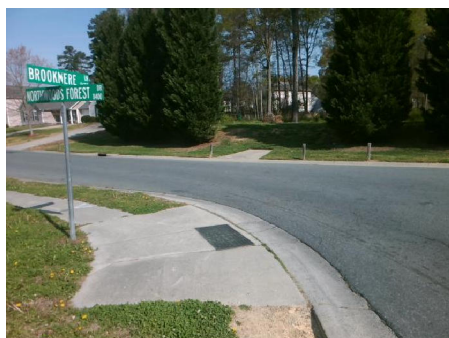
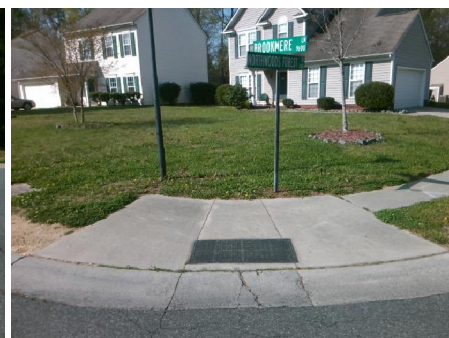
RP & RT RP < 5%

Not Found, R304.5.1, R304.5.3

Remove & Replace Entire Ramp.
