# Access Compliance Report

## Public Rights-of-Way

### (Curb Ramps)

| Intersection ID: 10136 | Main Street: BURKHOLDER_RD | Cross Street: SHEETS_CR | Location: | N/A |

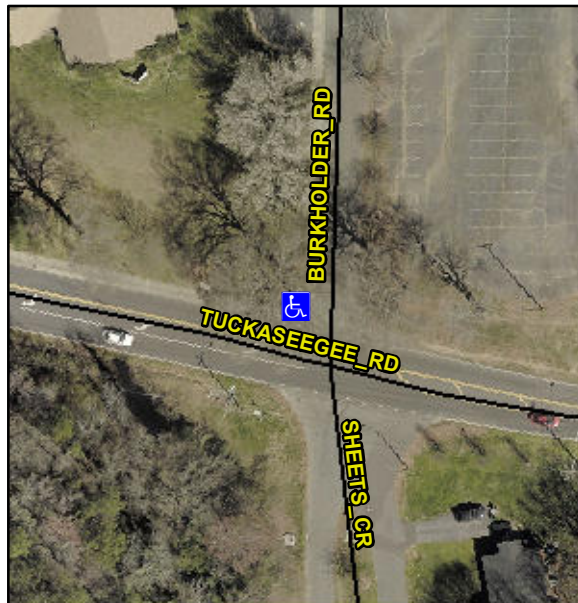
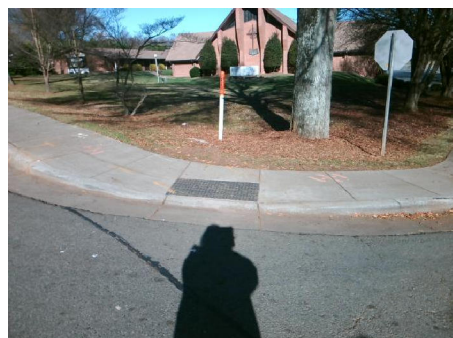
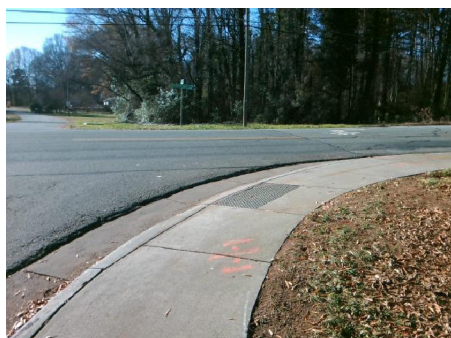
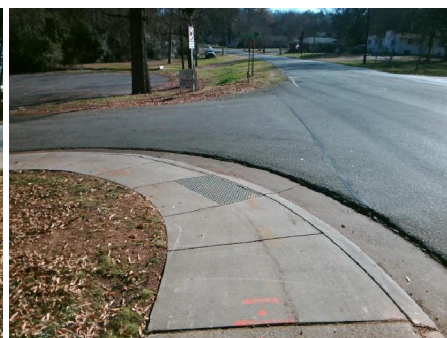
| ADA ID: DFD4A11703A1 | Ramp Type: Perp | Initial Pass/Fail: Fail | Overall Compliance: No | Severity Score: 33.75 |

**Not Found, R304.5.1, R304.5.3**

| Compliance | Description | Data | Compliance | Description | Data |
|---|---|---|---|---|---|
| No | Ramp Width (in) | 46.0 | No | Ramp XSlope (%) | 7.8 |

**Remove & Replace Entire Ramp.**
