Access Compliance Report

Public Rights-of-Way

(Curb Ramps)

Intersection ID: 8766	Main Street: ESTELLE_RD	Cross Street: MARIBEL_AV	Location:	S
ADA ID: DFE51DA6BBFE	Ramp Type: Perp	Initial Pass/Fail: Fail	Overall Compliance: No	Severity Score: 22.5

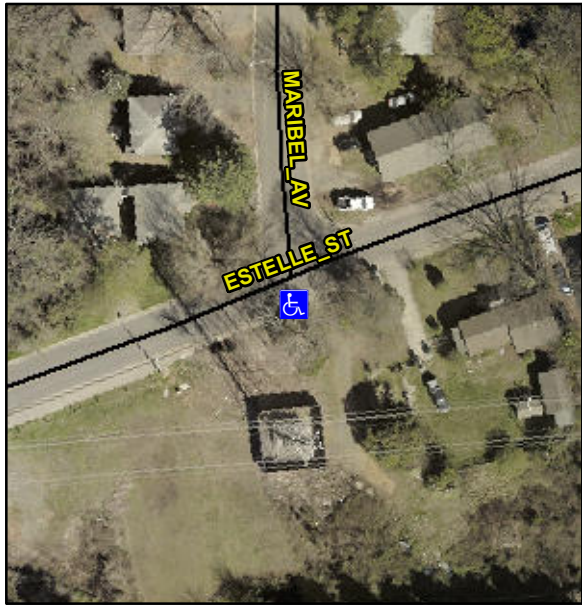
Possible Solutions:		Compliance	Description	Data	Compliance	Description	Data
	Remove & Replace Entire Ramp.		N/A	Ramp Length (in)	25.5	No	Ramp Slope (%)	8.5
			No	Ramp Width (in)	46.5	No	Ramp XSlope (%)	4.8
			N/A	Flare Type LT	N/A	N/A	Flare Type RT	N/A
			N/A	Flare Slope LT (%)	N/A	N/A	Flare Slope RT (%)	N/A
			N/A	Flare Traversable LT?	N/A	N/A	Flare Traversable RT?	N/A
			N/A	Landing Length (in)	N/A	N/A	DWS Provided?	N/A
			N/A	Landing Width (in)	N/A	N/A	DWS Contrast?	N/A
			N/A	Landing Slope (%)	N/A	N/A	DWS Length (in)	N/A
			N/A	Landing X Slope (%)	N/A	N/A	DWS Full Width?	N/A
Surveyor Notes:			N/A	Landing Curb? (Y/N)	N/A	N/A	DWS Offset (in)	N/A
N/A			N/A	Shared Landing?	N/A			
PROW/ADA:			N/A	Gutter Ponding?	N/A	N/A	Gutter Slope (%)	N/A
R304.5.1, R304.2.2, R304.5.3			N/A	Gutter Lip Ht (in)	N/A	N/A	Gutter X Slope (%)	N/A
