Access Compliance Report

Public Rights-of-Way

(Curb Ramps)

Intersection ID: 23880	Main Street: CHINA GROVE CHURCH RD	Cross Street: STERLING LN	Location: SW
ADA ID: DFFC26CCB237	Ramp Type: PerpDiag	Initial Pass/Fail: Fail	Overall Compliance: No
Severity Score: 46.25			
Codes/Mitigation Info/Possible Solution		Field Measurements/Component Compliance

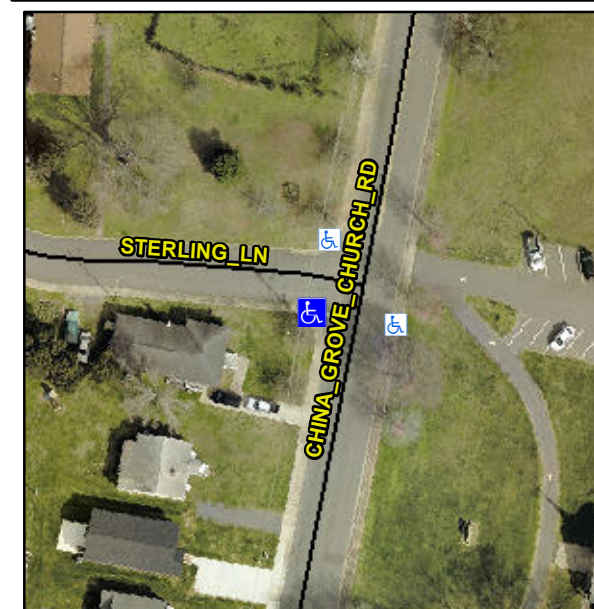
R304.5.1, R304.2.2, R304.5.3

Compliance	Description	Data	Compliance	Description	Data
N/A	Ramp Length (in)	48.0	No	Ramp Slope (%)	14.9
No	Ramp Width (in)	37.0	No	Ramp XSlope (%)	5.1
N/A	Flare Type LT	N/A	N/A	Flare Type RT	N/A
N/A	Flare Slope LT (%)	N/A	N/A	Flare Slope RT (%)	N/A
N/A	Flare Traversable LT?	N/A	N/A	Flare Traversable RT?	N/A
N/A	Landing Length (in)	N/A	N/A	DWS Provided?	N/A
N/A	Landing Width (in)	N/A	N/A	DWS Contrast?	N/A
N/A	Landing Slope (%)	N/A	N/A	DWS Length (in)	N/A
N/A	Landing X Slope (%)	N/A	N/A	DWS Full Width?	N/A
N/A	Landing Curb? (Y/N)	N/A	N/A	DWS Offset (in)	N/A
N/A	Shared Landing?	N/A			
N/A	Gutter Ponding?	N/A	N/A	Gutter Slope (%)	N/A
N/A	Gutter Lip Ht (in)	N/A	N/A	Gutter X Slope (%)	N/A
N/A	Painted X Walk1?	No	N/A	Painted X Walk2?	No
	X Walk 1 Direction	To SE		X Walk 2 Direction	To NE
N/A	X Walk 1 Width (in)	N/A	N/A	X Walk 2 Width (in)	N/A
	X Walk 1 Slope (%)	2.6		X Walk 2 Slope (%)	2.0
	X Walk 1 X Slope (%)	0.6		X Walk 2 X Slope (%)	6.6

Remove & Replace Curb Ramp With Two New Directional Ramps or Equivalent.
