# Access Compliance Report

## Public Rights-of-Way

### (Curb Ramps)

| Intersection ID: N/A | Main Street: SPRINGWOOD_ESTATE_DR | Cross Street: BELVEDERE_CASTLE_DR | Location: NW |

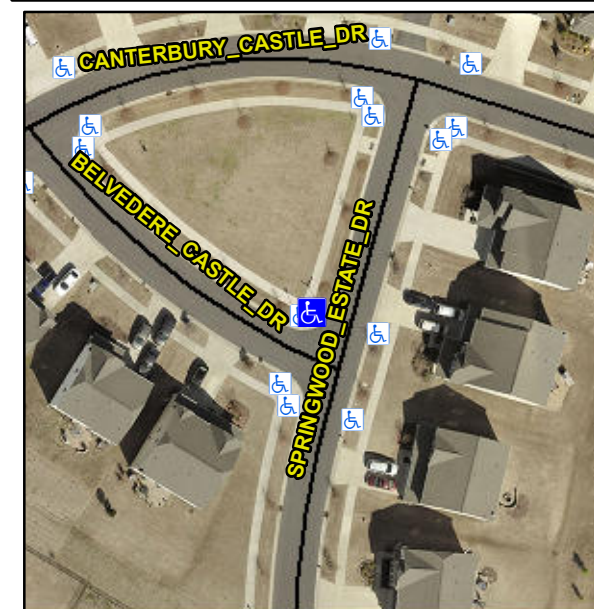
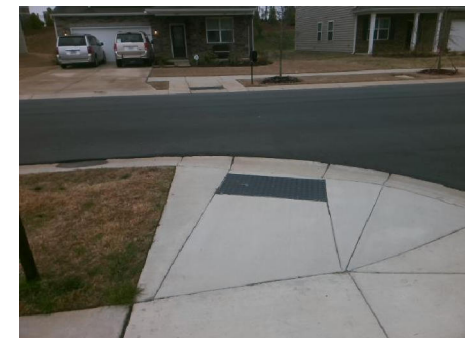
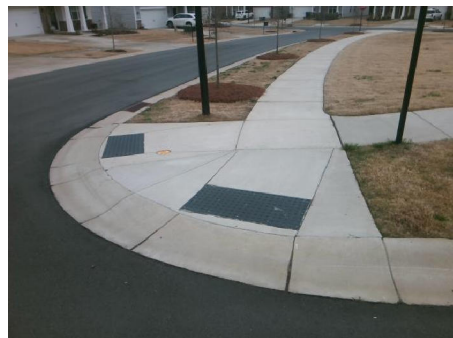
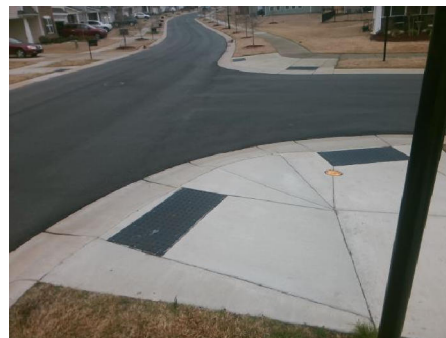
| ADA ID: E02C0E638283 | Ramp Type: BlendTrans1 | Initial Pass/Fail: Fail | Overall Compliance: No |
| Severity Score: 10 | | | |

**Not Found, R304.5.1, R304.5.3**

| Compliance | Description | Data | Compliance | Description | Data |
|---|---|---|---|---|---|
| No | Ramp Width (in) | 46.0 | No | BlendTrans XSlope (%) | 3.3 |

**Remove & Replace Curb Ramp With Two New Directional Ramps or Equivalent.**

Total Cost: \$ 3200.00
