Access Compliance Report

Public Rights-of-Way

(Curb Ramps)

Intersection ID: 14023	Main Street: NORWICH_PL	Cross Street: CHELVESTON_DR	Location: SE
ADA ID: E040A8FE517A	Ramp Type: Combination2Diag	Initial Pass/Fail: Fail	Overall Compliance: No
		Severity Score: 0

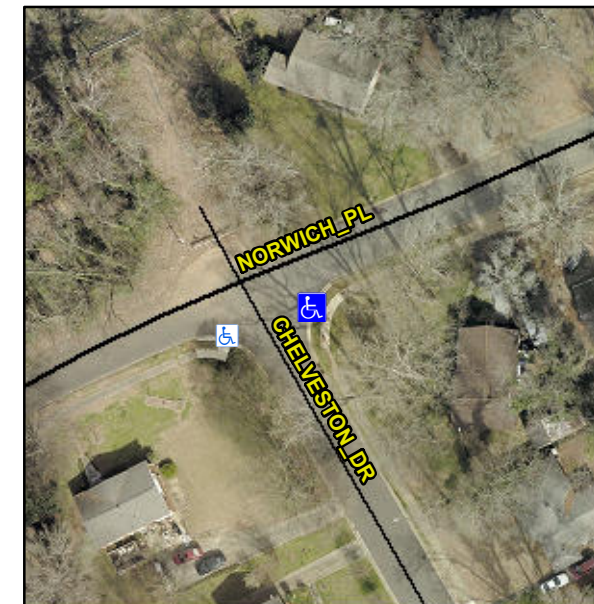
Not Found, R304.3.2

Remove & Replace Curb Ramp With Two New Directional Ramps or Equivalent.
