## Access Compliance Report Public Rights-of-Way (Curb Ramps)

Intersection ID: 12150 Main Street: W\_MARTIN\_LUTHER\_KING\_JRCEO/ss Street: S\_GRAHAM\_ST Location: W

ADA ID: E08F19908841 Ramp Type: Perp Initial Pass/Fail: Fail Overall Compliance: No Severity Score: 33.75

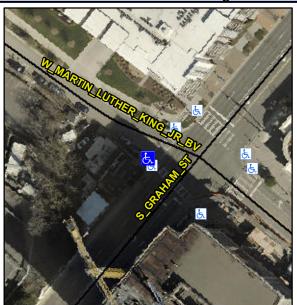
Field Measurements/Component Compliance						
Compliance Description		Data	Comp	liance Description	Data	
N/A	Ramp Length (in)	86.0	Yes	Ramp Slope (%)	7.4	
No	Ramp Width (in)	44.0	No	Ramp XSlope (%)	7.4	
N/A	Flare Type LT	N/A	N/A	Flare Type RT	N/A	
N/A	Flare Slope LT (%)	N/A	N/A	Flare Slope RT (%)	N/A	
N/A	Flare Traversable LT?	N/A	N/A	Flare Traversable RT?	N/A	
N/A	Landing Length (in)	N/A	N/A	DWS Provided?	N/A	
N/A	Landing Width (in)	N/A	N/A	DWS Contrast?	N/A	
N/A	Landing Slope (%)	N/A	N/A	DWS Length (in)	N/A	
N/A	Landing X Slope (%)	N/A	N/A	DWS Full Width?	N/A	
N/A	Landing Curb? (Y/N)	N/A	N/A	DWS Offset (in)	N/A	
N/A	Shared Landing?	N/A				
N/A	Gutter Ponding?	N/A	N/A	Gutter Slope (%)	N/A	
N/A	Gutter Lip Ht (in)	N/A	N/A	Gutter X Slope (%)	N/A	
N/A	Painted X Walk1?	Yes	N/A	Painted X Walk2?	N/A	
	X Walk 1 Direction	To NE		X Walk 2 Direction	N/A	
N/A	X Walk 1 Width (in)	105.0	N/A	X Walk 2 Width (in)	N/A	
	X Walk 1 Slope (%)	7.6		X Walk 2 Slope (%)	N/A

X Walk 1 X Slope (%)	0.4		X Walk 2 X Slope (%)	N/A	
N/A	Ramp inside XWalk1?	Yes	N/A	Ramp inside XWalk2?	N/A	
	Road Slope (%)	N/A	N/A	Clear Space?	N/A	
	Road X Slope (%)	N/A	N/A	Clear Space to XWalk (in)	N/A	
N/A	Any Obstructions?	N/A	N/A	Storm Grate/Utility Hazard?	N/A	
	Obstruction Type			Storm Grate/Utility Type		
		N/A			N/A	
			Yes	Surface Condition? (G/P)	Good

OSSIDIE OCIULION	
Possible Solutions:	Co
Remove & Replace Entire Ramp.	N/A
•	No
	N/A
	N/A
	N/A
	N/A
Surveyor Notes:	N/A
N/A	N/A
	N/A
	N/A
	N/A
PROW/ADA:	N/A
R304.5.1, R304.5.3	N/A
,	N/A
	N/A

Total Cost: \$ 1850.00
