# Access Compliance Report

## Public Rights-of-Way

| Intersection ID: 53391 | Main Street: EBBETS_RD | Cross Street: VAWTER_DR | Location: SW |
| ADA ID: E0D029B6CECF | Ramp Type: Perp | Initial Pass/Fail: Fail | Overall Compliance: No |

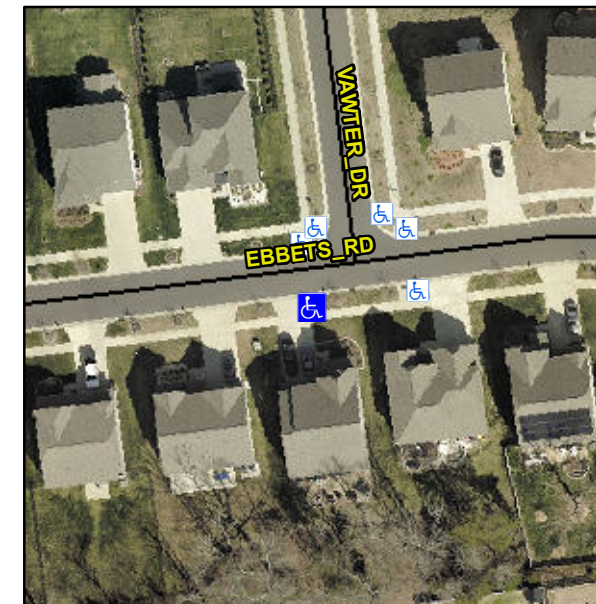
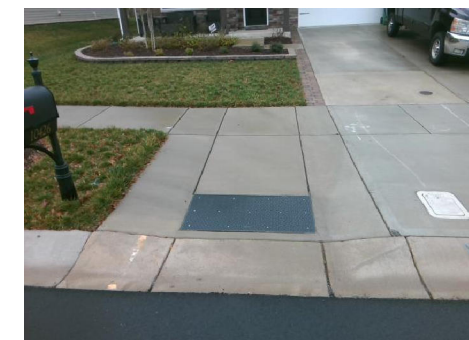
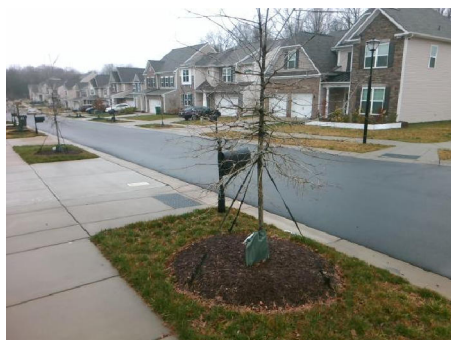
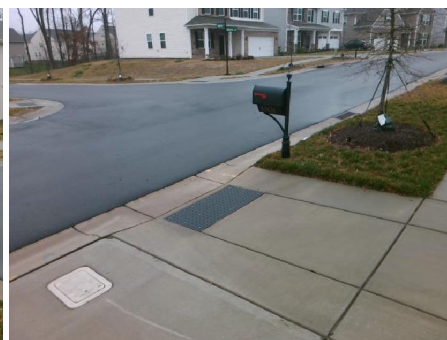
**R304.5.3**

| Compliance | Description | Data | Compliance | Description | Data |
|---|---|---|---|---|---|
| Yes | Ramp Width (in) | 48.0 | No | Ramp XSlope (%) | 6.8 |

**Remove & Replace Entire Ramp.**
