Access Compliance Report

Public Rights-of-Way

(Curb Ramps)

| Intersection ID: 28189 | Main Street: DARBY_CHASE_DR | Cross Street: JAMES_RICHARD_DR | Location: SW |

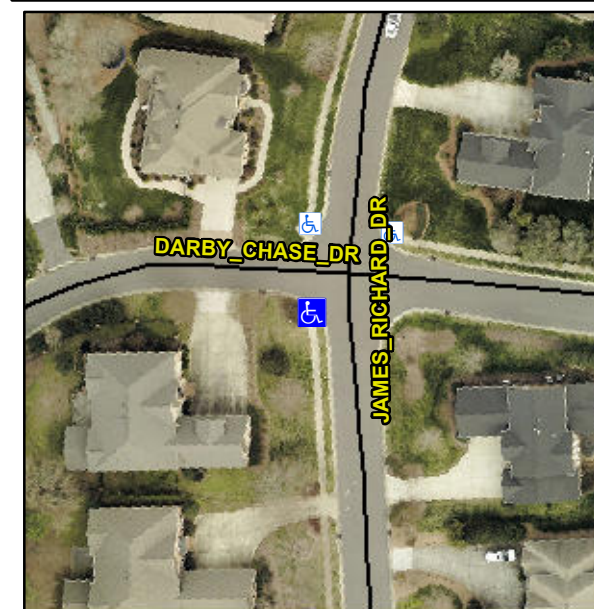
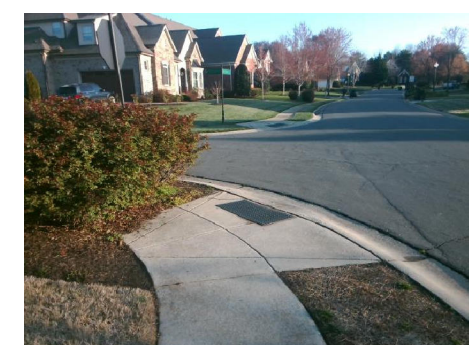
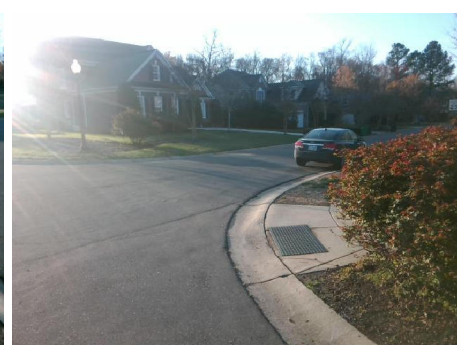
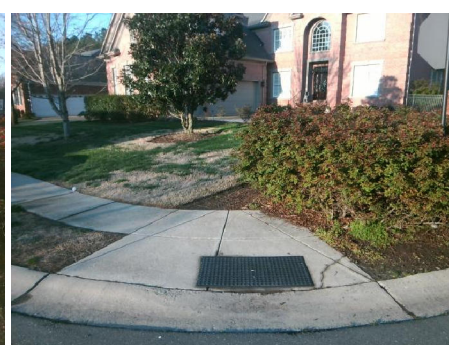
| ADA ID: E14EEE280D49 | Ramp Type: Perp | Initial Pass/Fail: Fail | Overall Compliance: No |
| Severity Score: 10 | | | |

R304.5.1, R304.5.3

| Compliance | Description | Data | Compliance | Description | Data |
|---|---|---|---|---|---|
| No | Ramp Width (in) | 38.0 | No | Ramp XSlope (%) | 2.1 |

Remove & Replace Entire Ramp.
