# Access Compliance Report

## Public Rights-of-Way

| Intersection ID: 49289 | Main Street: ARDREY_CREST_DR | Cross Street: ELIZABETH_CREST_LN | Location: SW |
| ADA ID: E15D7800BBE0 | Ramp Type: Perp | Initial Pass/Fail: Fail | Overall Compliance: No |

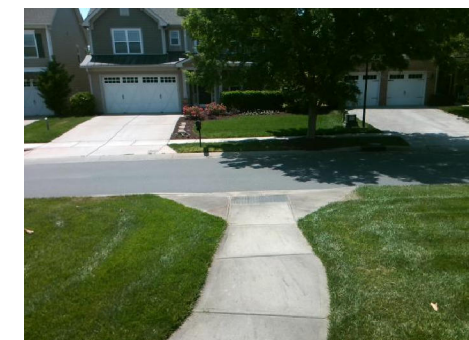
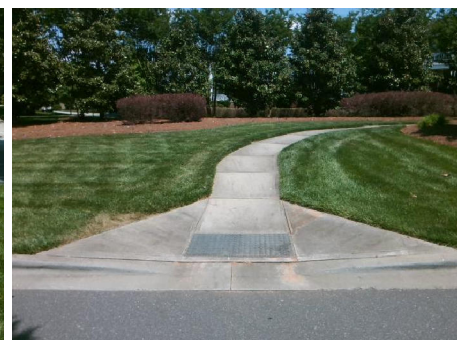
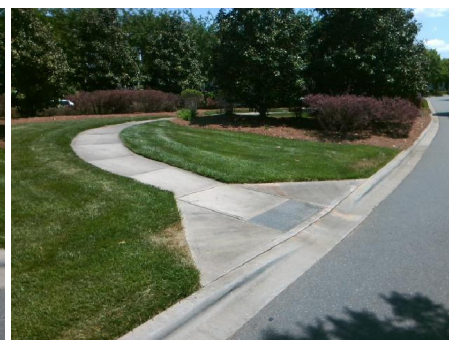
**Not Found, R304.5.1**

| Compliance | Description | Data | Compliance | Description | Data |
|---|---|---|---|---|---|
| No | Ramp Width (in) | 47.0 | Yes | Ramp XSlope (%) | 1.3 |

**Remove & Replace Entire Ramp.**
