Intersection ID: 12040	Main Street: BELVEDERE_AV	Cross Street: THURMOND_PL	Location:	N
ADA ID: E18B0023584B	Ramp Type: Para	Initial Pass/Fail: Fail	Overall Compliance: No	Severity Score: 13.75

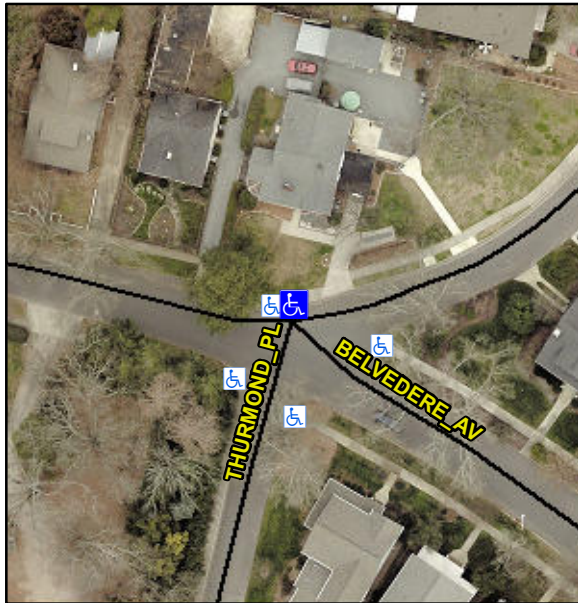
LT RP < 5%

R304.3.2, R304.5.3

Remove & Replace Entire Ramp.
