# Access Compliance Report

## Public Rights-of-Way

### (Curb Ramps)

| Intersection ID: 23437 | Main Street: MOSS_RD | Cross Street: S_TRYON_ST | Location: NW |

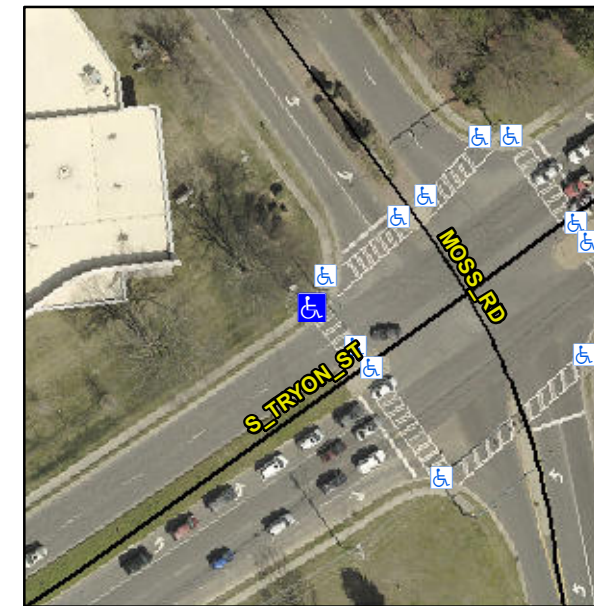
| ADA ID: E1BA3400E234 | Ramp Type: Perp | Initial Pass/Fail: Fail | Overall Compliance: No |
| | | Severity Score: 10 | |

**R304.5.1, R304.5.3**

| Compliance | Description | Data | Compliance | Description | Data |
|---|---|---|---|---|---|
| No | Ramp Width (in) | 46.0 | No | Ramp XSlope (%) | 2.2 |

**Remove & Replace Entire Ramp.**

Total Cost: \$ 1850.00
