# Access Compliance Report

## Public Rights-of-Way

### (Curb Ramps)

| Intersection ID: 24428 | Main Street: PRESCOTT_POND_LN | Cross Street: SAINTFIELD_PL | Location: NW |

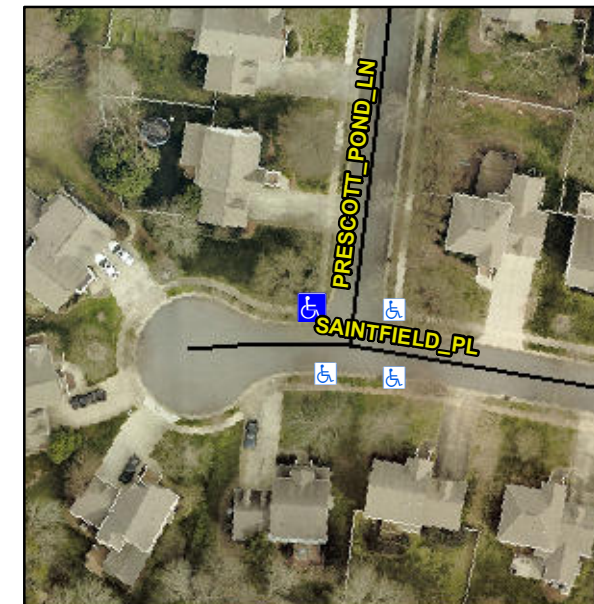
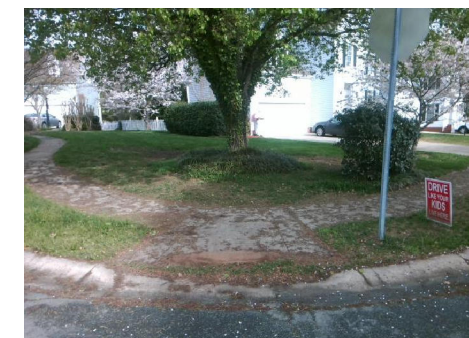
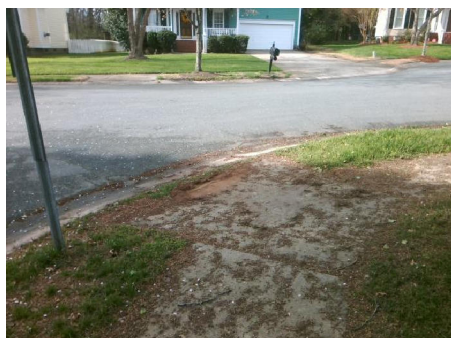
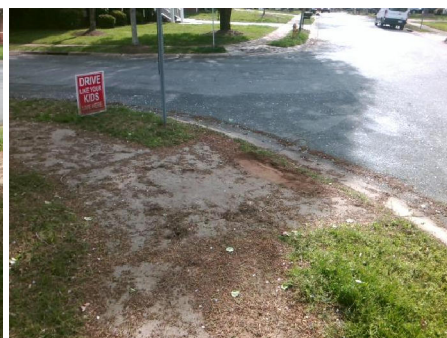
| ADA ID: E1E4E774C507 | Ramp Type: PerpDiag | Initial Pass/Fail: Fail | Overall Compliance: No |
| Severity Score: 13.75 | | | |

**R304.2.2, R304.5.3**

| Compliance | Description | Data | Compliance | Description | Data |
|---|---|---|---|---|---|
| N/A | Ramp Length (in) | 58.0 | No | Ramp Slope (%) | 8.5 |
| Yes | Ramp Width (in) | 48.0 | No | Ramp XSlope (%) | 2.2 |

**Remove & Replace Curb Ramp With Two New Directional Ramps or Equivalent.**
