## **Access Compliance Report Public Rights-of-Way** (Curb Ramps)

Intersection ID: 11903 Main Street: COUNTRY CLUB LN **Cross Street: MECKLENBURG AV** Location: SE ADA ID: E200A2439AB5 Ramp Type: Perp Initial Pass/Fail: Fail **Overall Compliance: No Severity Score:** 55

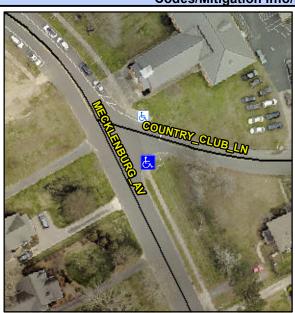
Field Measurements/Component Compliance					
Compliance Description		Data	Comp	liance Description	Data
N/A	Ramp Length (in)	61.0	No	Ramp Slope (%)	9.1
No	Ramp Width (in)	32.0	No	Ramp XSlope (%)	8.9
N/A	Flare Type LT	N/A	N/A	Flare Type RT	N/A
N/A	Flare Slope LT (%)	N/A	N/A	Flare Slope RT (%)	N/A
N/A	Flare Traversable LT?	N/A	N/A	Flare Traversable RT?	N/A
N/A	Landing Length (in)	N/A	N/A	DWS Provided?	N/A
N/A	Landing Width (in)	N/A	N/A	DWS Contrast?	N/A
N/A	Landing Slope (%)	N/A	N/A	DWS Length (in)	N/A
N/A	Landing X Slope (%)	N/A	N/A	DWS Full Width?	N/A
N/A	Landing Curb? (Y/N)	N/A	N/A	DWS Offset (in)	N/A
N/A	Shared Landing?	N/A			
N/A	Gutter Ponding?	N/A	N/A	Gutter Slope (%)	N/A
N/A	Gutter Lip Ht (in)	N/A	N/A	Gutter X Slope (%)	N/A
N/A	Painted X Walk1?	No	N/A	Painted X Walk2?	N/A
	X Walk 1 Direction	To N		X Walk 2 Direction	N/A
N/A	X Walk 1 Width (in)	N/A	N/A	X Walk 2 Width (in)	N/A
	X Walk 1 Slope (%)	8.3		X Walk 2 Slope (%)	N/A

Possible Solutions: Remove & Replace Entire Ramp. Surveyor Notes: N/A PROW/ADA: Not Found, R304.5.1, R304.2.2, R304.5.3
