| Intersection ID: 8037 | Main Street: AUSTIN_DR | Cross Street: ELGYWOOD_LN | Location: | NW |
| ADA ID: E2A2BF9611C7 | Ramp Type: Para | Initial Pass/Fail: Fail | Overall Compliance: No | Severity Score: 12.5 |

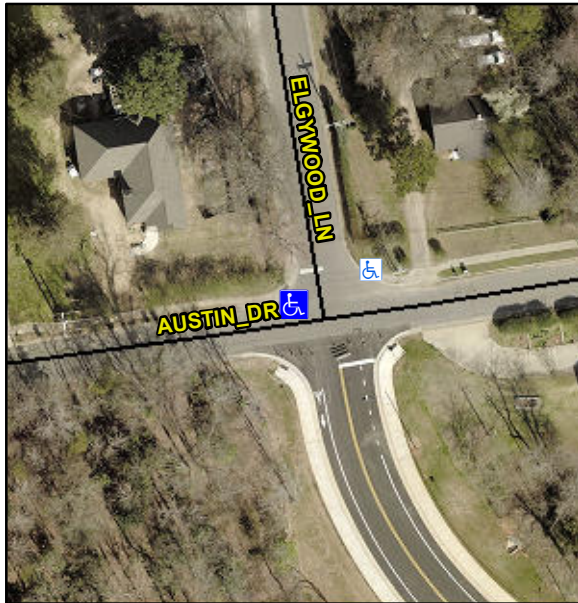
**CURB GAP 1.0, LT RP < 5%**

### R304.3.2

| Compliance | Description | Data | Compliance | Description | Data |
|---|---|---|---|---|---|
| Yes | Ramp Slope LT (%) | 0.6 | No | Ramp Slope RT (%) | 9.9 |

### Remove & Replace Entire Ramp.
