# Access Compliance Report

## Public Rights-of-Way

### (Curb Ramps)

| Intersection ID: 2573 | Main Street: CAMBELLTON_DR | Cross Street: PELORUS_LN | Location: SW |

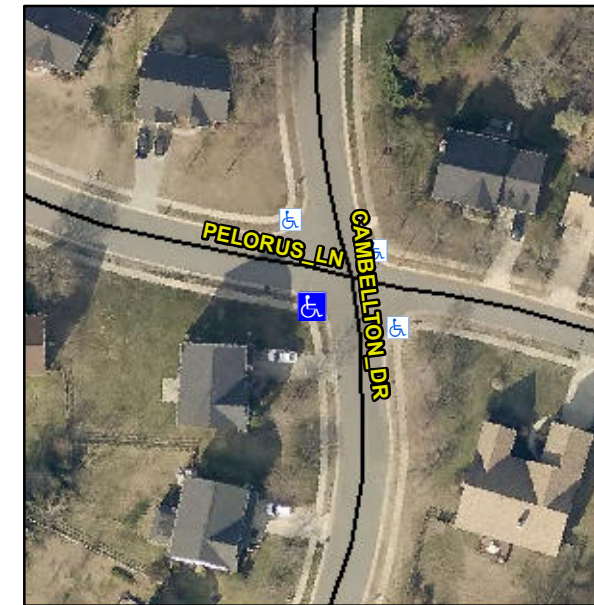
| ADA ID: E2A8ACD2EAAA | Ramp Type: PerpDiag | Initial Pass/Fail: Fail | Overall Compliance: No |
| | | | Severity Score: 26.25 |

**R304.2.2, R304.5.3**

| Compliance | Description | Data | Compliance | Description | Data |
|---|---|---|---|---|---|
| N/A | Ramp Length (in) | 45.5 | No | Ramp Slope (%) | 14.7 |
| Yes | Ramp Width (in) | 64.0 | No | Ramp XSlope (%) | 3.6 |

**Remove & Replace Curb Ramp With Two New Directional Ramps or Equivalent.**

Total Cost: \$ 3200.00
