# Access Compliance Report

## Public Rights-of-Way

### (Curb Ramps)

Intersection ID: 44463	Main Street: BUCKHORN_ST	Cross Street: VALCOURT_RD	Location: SE
ADA ID: E2D7CCCEDE6F	Ramp Type: PerpDiag	Initial Pass/Fail: Fail	Overall Compliance: No
Codes/Mitigation Info/Possible Solution			Severity Score: 10
			Field Measurements/Component Compliance

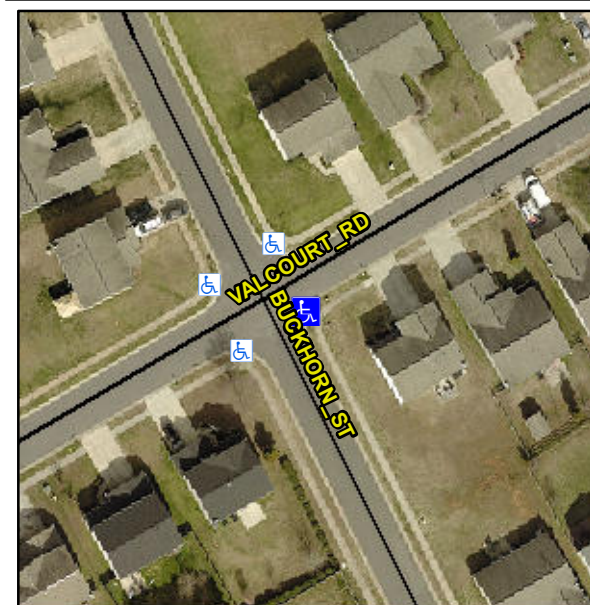
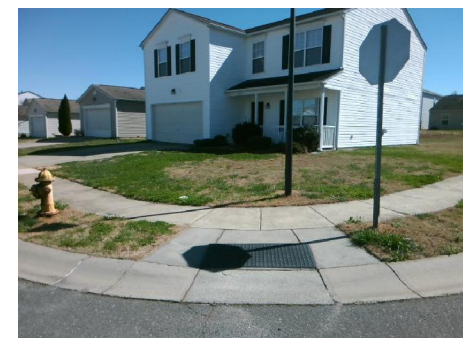
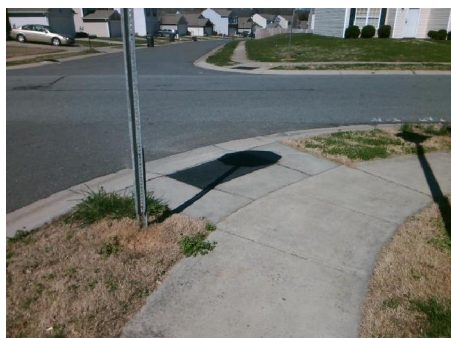
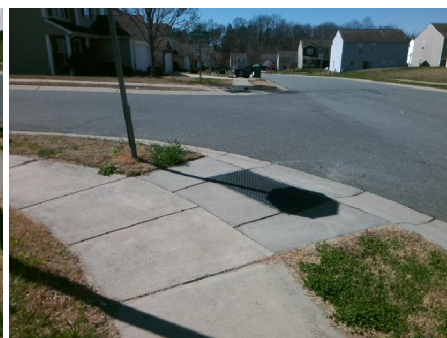
**Not Found, R304.5.1, R304.5.3**

Compliance	Description	Data	Compliance	Description	Data
N/A	Ramp Length (in)	49.0	Yes	Ramp Slope (%)	5.0
No	Ramp Width (in)	37.0	No	Ramp XSlope (%)	2.9
N/A	Flare Type LT	N/A	N/A	Flare Type RT	N/A
N/A	Flare Slope LT (%)	N/A	N/A	Flare Slope RT (%)	N/A
N/A	Flare Traversable LT?	N/A	N/A	Flare Traversable RT?	N/A
N/A	Landing Length (in)	N/A	N/A	DWS Provided?	N/A
N/A	Landing Width (in)	N/A	N/A	DWS Contrast?	N/A
N/A	Landing Slope (%)	N/A	N/A	DWS Length (in)	N/A
N/A	Landing X Slope (%)	N/A	N/A	DWS Full Width?	N/A
N/A	Landing Curb? (Y/N)	N/A	N/A	DWS Offset (in)	N/A
N/A	Shared Landing?	N/A			
N/A	Gutter Ponding?	N/A	N/A	Gutter Slope (%)	N/A
N/A	Gutter Lip Ht (in)	N/A	N/A	Gutter X Slope (%)	N/A
N/A	Painted X Walk1?	No	N/A	Painted X Walk2?	No
	X Walk 1 Direction	To N		X Walk 2 Direction	To W
N/A	X Walk 1 Width (in)	N/A	N/A	X Walk 2 Width (in)	N/A
	X Walk 1 Slope (%)	1.9		X Walk 2 Slope (%)	0.9
	X Walk 1 X Slope (%)	1.0		X Walk 2 X Slope (%)	2.6

N/A	Ramp inside XWalk1?	N/A	N/A	Ramp inside XWalk2?	N/A
	Road Slope (%)	0.9	N/A	Clear Space?	N/A
	Road X Slope (%)	1.3	N/A	Clear Space to XWalk (in)	N/A
N/A	Any Obstructions?	N/A	N/A	Storm Grate/Utility Hazard?	N/A
	Obstruction Type			Storm Grate/Utility Type	
		N/A			N/A
			Yes	Surface Condition? (G/P)	Good

Possible Solutions:

**Remove & Replace Curb Ramp With Two New Directional Ramps or Equivalent.**
