# Access Compliance Report

## Public Rights-of-Way

| Intersection ID: 10024743 | Main Street: DEER RIDGE LN | Cross Street: N/A | Location: SW |
| ADA ID: E3120F50FB15 | Ramp Type: Perp | Initial Pass/Fail: Fail | Overall Compliance: No |

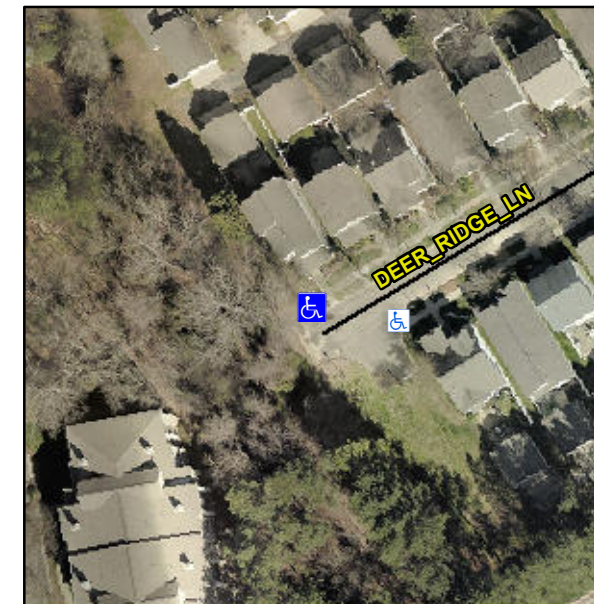
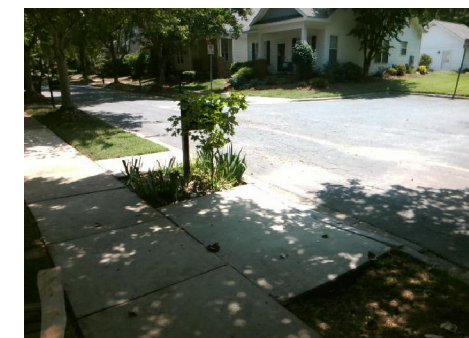
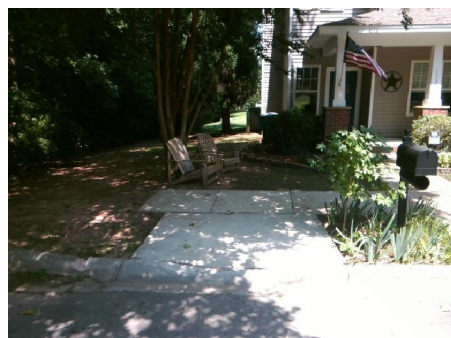
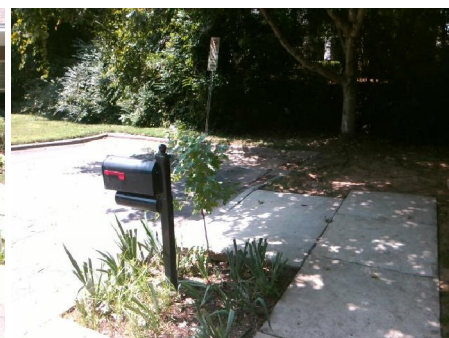
| Severity Score: 21.25 | | | |

**Not Found, R304.5.1, R304.2.2**

| Compliance | Description | Data | Compliance | Description | Data |
|---|---|---|---|---|---|
| N/A | Ramp Length (in) | 60.0 | No | Ramp Slope (%) | 8.5 |
| No | Ramp Width (in) | 36.0 | Yes | Ramp XSlope (%) | 1.1 |

**Remove & Replace Entire Ramp.**

Total Cost: \$ 1850.00
