Intersection ID: 18800	Main Street: PARK_RD	Cross Street: SENECA_PL	Location:	NE
ADA ID: E32BC56BB711	Ramp Type: PerpDiag	Initial Pass/Fail: Fail	Overall Compliance: No	Severity Score: 12.5

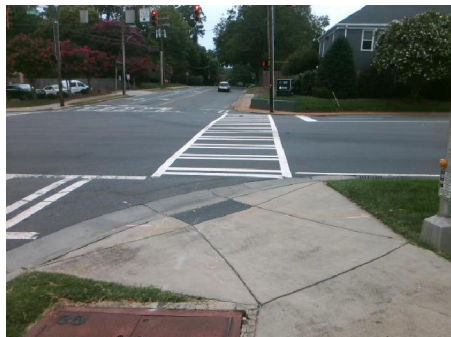
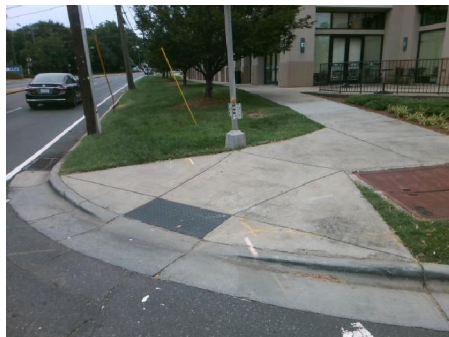
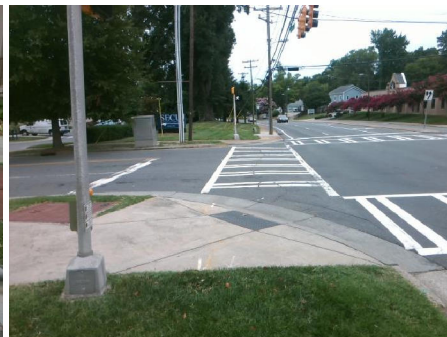
Compliance	Description	Data	Compliance	Description	Data
N/A	Ramp Length (in)	112.0	No	Ramp Slope (%)	8.9
Yes	Ramp Width (in)	49.0	Yes	Ramp XSlope (%)	0.8
N/A	Flare Type LT	N/A	N/A	Flare Type RT	N/A
N/A	Flare Slope LT (%)	N/A	N/A	Flare Slope RT (%)	N/A
N/A	Flare Traversable LT?	N/A	N/A	Flare Traversable RT?	N/A
N/A	Landing Length (in)	N/A	N/A	DWS Provided?	N/A
N/A	Landing Width (in)	N/A	N/A	DWS Contrast?	N/A
N/A	Landing Slope (%)	N/A	N/A	DWS Length (in)	N/A
N/A	Landing X Slope (%)	N/A	N/A	DWS Full Width?	N/A
N/A	Landing Curb? (Y/N)	N/A	N/A	DWS Offset (in)	N/A
N/A	Shared Landing?	N/A			
N/A	Gutter Ponding?	N/A	N/A	Gutter Slope (%)	N/A
N/A	Gutter Lip Ht (in)	N/A	N/A	Gutter X Slope (%)	N/A
N/A	Painted X Walk1?	Yes	N/A	Painted X Walk2?	Yes
	X Walk 1 Direction	To W		X Walk 2 Direction	To S
N/A	X Walk 1 Width (in)	110.0	N/A	X Walk 2 Width (in)	108.0
	X Walk 1 Slope (%)	3.3		X Walk 2 Slope (%)	2.2
	X Walk 1 X Slope (%)	0.5		X Walk 2 X Slope (%)	1.0

N/A	Ramp inside XWalk1?	Yes	N/A	Ramp inside XWalk2?	Yes
	Road Slope (%)	2.3	N/A	Clear Space?	N/A
	Road X Slope (%)	3.3	N/A	Clear Space to XWalk (in)	N/A
N/A	Any Obstructions?	N/A	N/A	Storm Grate/Utility Hazard?	N/A
	Obstruction Type			Storm Grate/Utility Type	
		N/A			N/A
			Yes	Surface Condition? (G/P)	Good

**Remove & Replace Curb Ramp With Two New Directional Ramps or Equivalent.**
