Access Compliance Report Public Rights-of-Way (Curb Ramps)

Intersection ID: 44922 Main Street: MAPLE_PARK_LN Cross Street: ROBUR_CT Location: E

ADA ID: E3659151DAC1 Ramp Type: Perp Initial Pass/Fail: Fail Overall Compliance: No Severity Score: 12.5

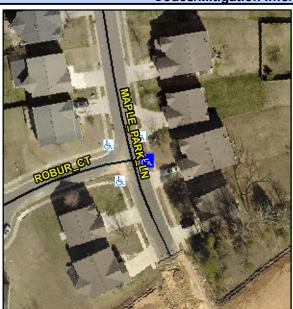
Field Measurements/Component Compliance							
Comp	iance Description	Data	Comp	liance Description	Data		
N/A	Ramp Length (in)	49.0	No	Ramp Slope (%)	11.5		
Yes	Ramp Width (in)	48.0	Yes	Ramp XSlope (%)	1.4		
N/A	Flare Type LT	N/A	N/A	Flare Type RT	N/A		
N/A	Flare Slope LT (%)	N/A	N/A	Flare Slope RT (%)	N/A		
N/A	Flare Traversable LT?	N/A	N/A	Flare Traversable RT?	N/A		
N/A	Landing Length (in)	N/A	N/A	DWS Provided?	N/A		
N/A	Landing Width (in)	N/A	N/A	DWS Contrast?	N/A		
N/A	Landing Slope (%)	N/A	N/A	DWS Length (in)	N/A		
N/A	Landing X Slope (%)	N/A	N/A	DWS Full Width?	N/A		
N/A	Landing Curb? (Y/N)	N/A	N/A	DWS Offset (in)	N/A		
N/A	Shared Landing?	N/A					
N/A	Gutter Ponding?	N/A	N/A	Gutter Slope (%)	N/A		
N/A	Gutter Lip Ht (in)	N/A	N/A	Gutter X Slope (%)	N/A		
N/A	Painted X Walk1?	No	N/A	Painted X Walk2?	N/A		
	X Walk 1 Direction	To W		X Walk 2 Direction	N/A		
N/A	X Walk 1 Width (in)	N/A	N/A	X Walk 2 Width (in)	N/A

X Walk 1 Slope (%)	3.7		X Walk 2 Slope (%)	N/A		
	X Walk 1 X Slope (%)	2.3		X Walk 2 X Slope (%)	N/A		
N/A	Ramp inside XWalk1?	N/A	N/A	Ramp inside XWalk2?	N/A		
	Road Slope (%)	N/A	N/A	Clear Space?	N/A		
	Road X Slope (%)	N/A	N/A	Clear Space to XWalk (in)	N/A		
N/A	Any Obstructions?	N/A	N/A	Storm Grate/Utility Hazard?	N/A		
	Obstruction Type			Storm Grate/Utility Type			
		N/A			N/A		
			Yes	Surface Condition? (G/P)	Good

Possible Solutions:	Com
Remove & Replace Entire Ramp.	N/A
·	Yes
	N/A
	N/A
	N/A
	N/A
Surveyor Notes:	N/A
N/A	N/A
	N/A
	N/A
	N/A
PROW/ADA:	N/A
Not Found, R304.2.2	N/A
,	N/A
	N/A
	N/A

1850.00
