Access Compliance Report

Public Rights-of-Way

Intersection ID: 26030	Main Street: BAYBROOK_LN	Cross Street: REAFIELD_DR	Location: E
ADA ID: E393B13CEE35	Ramp Type: PerpDiag	Initial Pass/Fail: Fail	Overall Compliance: No
Severity Score: 22.5			
Codes/Mitigation Info/Possible Solution		Field Measurements/Component Compliance

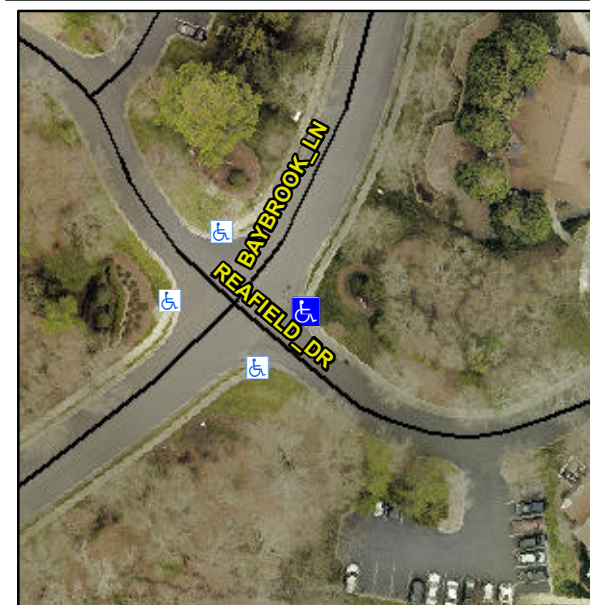
Not Found, R304.5.1, R304.2.2, R304.5.3

Compliance	Description	Data	Compliance	Description	Data
N/A	Ramp Length (in)	47.0	No	Ramp Slope (%)	9.6
No	Ramp Width (in)	47.0	No	Ramp XSlope (%)	5.0
N/A	Flare Type LT	N/A	N/A	Flare Type RT	N/A
N/A	Flare Slope LT (%)	N/A	N/A	Flare Slope RT (%)	N/A
N/A	Flare Traversable LT?	N/A	N/A	Flare Traversable RT?	N/A
N/A	Landing Length (in)	N/A	N/A	DWS Provided?	N/A
N/A	Landing Width (in)	N/A	N/A	DWS Contrast?	N/A
N/A	Landing Slope (%)	N/A	N/A	DWS Length (in)	N/A
N/A	Landing X Slope (%)	N/A	N/A	DWS Full Width?	N/A
N/A	Landing Curb? (Y/N)	N/A	N/A	DWS Offset (in)	N/A
N/A	Shared Landing?	N/A			
N/A	Gutter Ponding?	N/A	N/A	Gutter Slope (%)	N/A
N/A	Gutter Lip Ht (in)	N/A	N/A	Gutter X Slope (%)	N/A
N/A	Painted X Walk1?	No	N/A	Painted X Walk2?	No
	X Walk 1 Direction	To NW		X Walk 2 Direction	To SW
N/A	X Walk 1 Width (in)	N/A	N/A	X Walk 2 Width (in)	N/A
	X Walk 1 Slope (%)	1.5		X Walk 2 Slope (%)	0.9
	X Walk 1 X Slope (%)	1.5		X Walk 2 X Slope (%)	1.0

Remove & Replace Curb Ramp With Two New Directional Ramps or Equivalent.

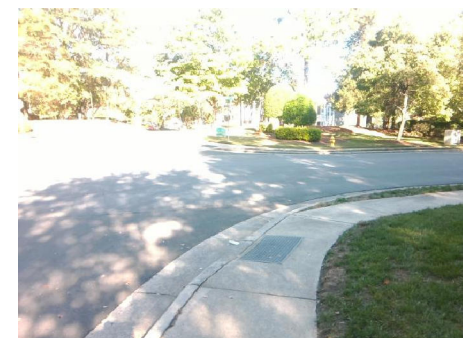
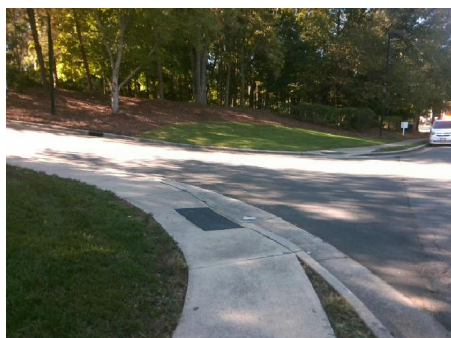
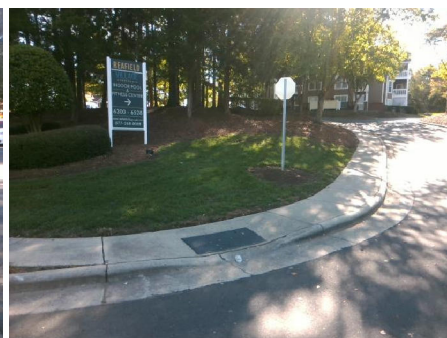
N/A	Ramp inside XWalk1?	N/A	N/A	Ramp inside XWalk2?	N/A
	Road Slope (%)	2.8	N/A	Clear Space?	N/A
	Road X Slope (%)	0.7	N/A	Clear Space to XWalk (in)	N/A
N/A	Any Obstructions?	N/A	N/A	Storm Grate/Utility Hazard?	N/A
	Obstruction Type			Storm Grate/Utility Type	
		N/A			N/A
			Yes	Surface Condition? (G/P)	Good
