## **Access Compliance Report Public Rights-of-Way** (Curb Ramps)

Intersection ID: 8059 Main Street: BILMARK\_AV Cross Street: CINDERELLA\_RD Location: NE **Overall Compliance: No Severity Score:** ADA ID: E424082E7C42 Ramp Type: Perp Initial Pass/Fail: Fail 8.75

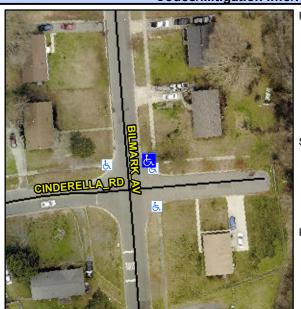
Field Measurements/Component Compliance								
Comp	liance Description	Data	Comp	liance Description	Data			
N/A	Ramp Length (in)	33.5	Yes	Ramp Slope (%)	5.5			
No	Ramp Width (in)	40.5	Yes	Ramp XSlope (%)	0.2			
N/A	Flare Type LT	N/A	N/A	Flare Type RT	N/A			
N/A	Flare Slope LT (%)	N/A	N/A	Flare Slope RT (%)	N/A			
N/A	Flare Traversable LT?	N/A	N/A	Flare Traversable RT?	N/A			
N/A	Landing Length (in)	N/A	N/A	DWS Provided?	N/A			
N/A	Landing Width (in)	N/A	N/A	DWS Contrast?	N/A			
N/A	Landing Slope (%)	N/A	N/A	DWS Length (in)	N/A			
N/A	Landing X Slope (%)	N/A	N/A	DWS Full Width?	N/A			
N/A	Landing Curb? (Y/N)	N/A	N/A	DWS Offset (in)	N/A			
N/A	Shared Landing?	N/A						
N/A	Gutter Ponding?	N/A	N/A	Gutter Slope (%)	N/A			
N/A	Gutter Lip Ht (in)	1.0	N/A	Gutter X Slope (%)	N/A			
N/A	Painted X Walk1?	No	N/A	Painted X Walk2?	N/A			
	X Walk 1 Direction	To W		X Walk 2 Direction	N/A			
N/A	X Walk 1 Width (in)	N/A	N/A	X Walk 2 Width (in)	N/A

X Walk 1 Slope (%)	3.3		X Walk 2 Slope (%)	N/A			
	X Walk 1 X Slope (%)	0.0		X Walk 2 X Slope (%)	N/A			
N/A	Ramp inside XWalk1?	N/A	N/A	Ramp inside XWalk2?	N/A			
	Road Slope (%)	N/A	N/A	Clear Space?	N/A			
	Road X Slope (%)	N/A	N/A	Clear Space to XWalk (in)	N/A			
N/A	Any Obstructions?	N/A	N/A	Storm Grate/Utility Hazard?	N/A			
	Obstruction Type			Storm Grate/Utility Type				
		N/A			N/A			
			Yes	Surface Condition? (G/P)	Good

OSSIDIE SOIULIOII	
Possible Solutions:	Com
Remove & Replace Entire Ramp.	N/A
•	No
	N/A
	N/A
	N/A
	N/A
Surveyor Notes:	N/A
N/A	N/A
	N/A
	N/A
	N/A
PROW/ADA:	N/A
Not Found, R304.5.1	N/A
	N/A
	N/A
	N/A
