# Access Compliance Report

## Public Rights-of-Way

### (Curb Ramps)

Intersection ID: 28421	Main Street: ASTONBORO_DR	Cross Street: GOLDEN_DR	Location: NW
ADA ID: E442A7E89DD4	Ramp Type: Perp	Initial Pass/Fail: Fail	Overall Compliance: No
		Severity Score: 8.75

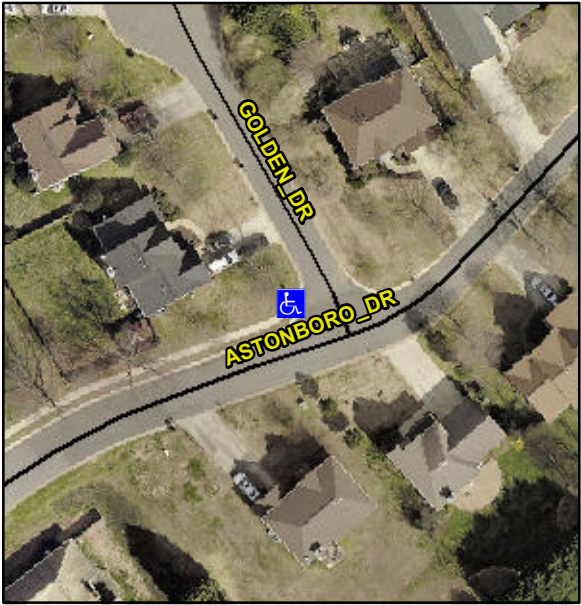
Possible Solutions:		<b>Compliance</b>	<b>Description</b>	<b>Data</b>
	<b>Remove &amp; Replace Entire Ramp.</b>		<b>Yes</b>	Ramp Length (in)	7.9
			<b>No</b>	Ramp Width (in)	1.8
			<b>N/A</b>	Flare Type LT	N/A
			<b>N/A</b>	Flare Slope LT (%)	N/A
			<b>N/A</b>	Flare Traversable LT?	N/A
			<b>N/A</b>	Landing Length (in)	N/A
			<b>N/A</b>	Landing Width (in)	N/A
			<b>N/A</b>	Landing Slope (%)	N/A
			<b>N/A</b>	Landing X Slope (%)	N/A
<p>Surveyor Notes:</p> <p><b>N/A</b></p> <p>PROW/ADA:</p> <p><b>Not Found, R304.5.1</b></p>			<b>N/A</b>	Flare Type RT	N/A
			<b>N/A</b>	Flare Slope RT (%)	N/A
			<b>N/A</b>	Flare Traversable RT?	N/A
			<b>N/A</b>	DWS Provided?	N/A
			<b>N/A</b>	DWS Contrast?	N/A
			<b>N/A</b>	DWS Length (in)	N/A
			<b>N/A</b>	DWS Full Width?	N/A
			<b>N/A</b>	DWS Offset (in)	N/A
			<b>N/A</b>	Shared Landing?	N/A

<b>N/A</b>	Gutter Ponding?	N/A
			<b>N/A</b>	Gutter Lip Ht (in)	N/A
			<b>No</b>	Painted X Walk1?	N/A
				X Walk 1 Direction	N/A
			<b>N/A</b>	X Walk 1 Width (in)	N/A
			<b>4.3</b>	X Walk 1 Slope (%)	N/A
			<b>1.9</b>	X Walk 1 X Slope (%)	N/A
			<b>N/A</b>	Ramp inside XWalk1?	N/A
			<b>1.9</b>	Road Slope (%)	N/A
			<b>4.3</b>	Road X Slope (%)	N/A
			<b>N/A</b>	Any Obstructions?	N/A
				Obstruction Type	N/A
			<b>N/A</b>		N/A
			<b>Yes</b>	Surface Condition? (G/P)	Good
