Access Compliance Report Public Rights-of-Way (Curb Ramps)

Intersection ID: 12305 Main Street: E_5TH_ST Cross Street: N_COLLEGE_ST Location: W

ADA ID: E4506F99723A Ramp Type: PerpDiag Initial Pass/Fail: Fail Overall Compliance: No Severity Score: 26.25

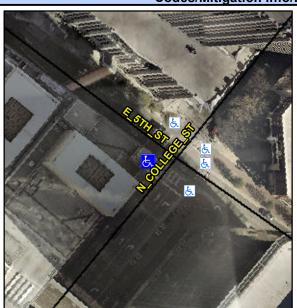
Not Found, R304.2.2, R304.5.3

Field Measurements/Component Compilance					
Compliance Description		Data	Compliance Description		Data
N/A	Ramp Length (in)	87.0	No	Ramp Slope (%)	13.1
Yes	Ramp Width (in)	48.0	No	Ramp XSlope (%)	3.8
N/A	Flare Type LT	N/A	N/A	Flare Type RT	N/A
N/A	Flare Slope LT (%)	N/A	N/A	Flare Slope RT (%)	N/A
N/A	Flare Traversable LT?	N/A	N/A	Flare Traversable RT?	N/A
N/A	Landing Length (in)	N/A	N/A	DWS Provided?	N/A
N/A	Landing Width (in)	N/A	N/A	DWS Contrast?	N/A
N/A	Landing Slope (%)	N/A	N/A	DWS Length (in)	N/A
N/A	Landing X Slope (%)	N/A	N/A	DWS Full Width?	N/A
N/A	Landing Curb? (Y/N)	N/A	N/A	DWS Offset (in)	N/A
N/A	Shared Landing?	N/A			
N/A	Gutter Ponding?	N/A	N/A	Gutter Slope (%)	N/A
N/A	Gutter Lip Ht (in)	N/A	N/A	Gutter X Slope (%)	N/A
N/A	Painted X Walk1?	Yes	N/A	Painted X Walk2?	Yes
	X Walk 1 Direction	To S		X Walk 2 Direction	To N
N/A	X Walk 1 Width (in)	106.0	N/A	X Walk 2 Width (in)	117.0
	X Walk 1 Slope (%)	1.3		X Walk 2 Slope (%)	4.9

X Walk 1 X Slope (%)	1.7		X Walk 2 X Slope (%)	3.7
N/A	Ramp inside XWalk1?	Yes	N/A	Ramp inside XWalk2?	Yes
	Road Slope (%)	2.4	N/A	Clear Space?	N/A
	Road X Slope (%)	0.9	N/A	Clear Space to XWalk (in)	N/A
N/A	Any Obstructions?	N/A	N/A	Storm Grate/Utility Hazard?	N/A
	Obstruction Type			Storm Grate/Utility Type	
		N/A			N/A
			Yes	Surface Condition? (G/P)	Good

Remove & Replace Curb Ramp With Two New Directional Ramps or Equivalent.
