Access Compliance Report

Public Rights-of-Way (Curb Ramps)

Intersection ID: 11331	Main Street: E_W_T_HARRIS_BV	Cross Street: MEADOW_ROSE_LN	Location: NE
ADA ID: E475F36130D5	Ramp Type: Combination1	Initial Pass/Fail: Fail	Overall Compliance: No
		Severity Score: 67.5

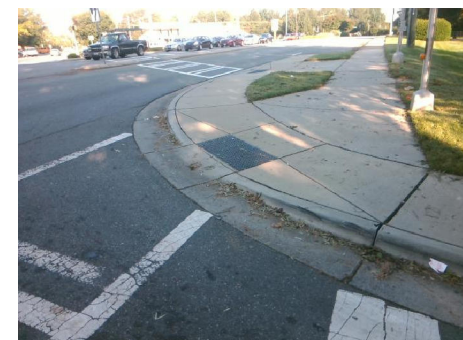
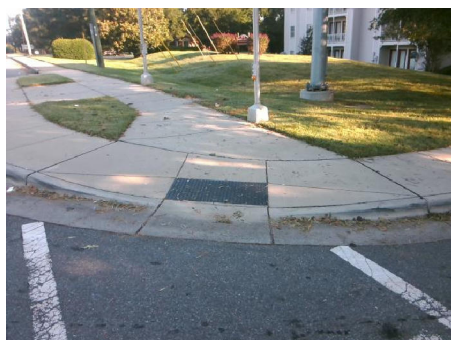
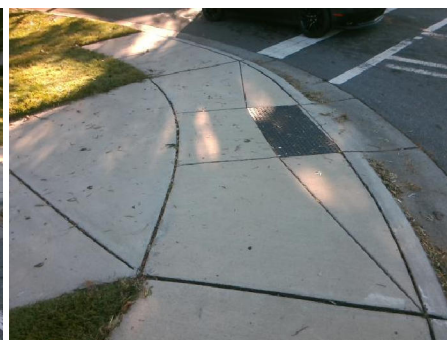
RT RP < 5%

**Not Found, R304.5.1, R304.5.3,
R304.3.2**

Compliance	Description	Data	Compliance	Description	Data
N/A	Ramp Length LT (in)	49.5	N/A	Ramp Length RT (in)	54.5
No	Ramp Width LT (in)	36.0	No	Ramp Width RT (in)	34.0
No	Ramp Slope LT (%)	14.5	Yes	Ramp Slope RT (%)	4.2
No	Ramp XSlope LT (%)	3.6	No	Ramp XSlope RT (%)	3.1
N/A	Ramp Length (in)	27.0	Yes	Ramp Slope (%)	6.1
Yes	Ramp Width (in)	48.0	No	Ramp XSlope (%)	7.4
N/A	Flare Type LT	N/A	N/A	Flare Type RT	N/A
N/A	Flare Slope LT (%)	N/A	N/A	Flare Slope RT (%)	N/A
N/A	Flare Traversable LT?	N/A	N/A	Flare Traversable RT?	N/A
N/A	Landing Length (in)	N/A	N/A	DWS Provided?	N/A
N/A	Landing Width (in)	N/A	N/A	DWS Contrast?	N/A
N/A	Landing Slope (%)	N/A	N/A	DWS Length (in)	N/A
N/A	Landing X Slope (%)	N/A	N/A	DWS Full Width?	N/A
N/A	Landing Curb? (Y/N)	N/A	N/A	DWS Offset (in)	N/A
N/A	Shared Landing?	N/A			
N/A	Gutter Ponding?	N/A	N/A	Gutter Slope (%)	N/A
N/A	Gutter Lip Ht (in)	N/A	N/A	Gutter X Slope (%)	N/A
N/A	Painted X Walk1?	Yes	N/A	Painted X Walk2?	N/A

X Walk 1 Direction	To SE		X Walk 2 Direction	N/A
	X Walk 1 Width (in)	89.0		X Walk 2 Width (in)	N/A
	X Walk 1 Slope (%)	2.7		X Walk 2 Slope (%)	N/A
	X Walk 1 X Slope (%)	6.5		X Walk 2 X Slope (%)	N/A
N/A	Ramp inside XWalk1?	Yes	N/A	Ramp inside XWalk2?	N/A
	Road Slope (%)	N/A		Clear Space?	N/A
	Road X Slope (%)	N/A	N/A	Clear Space to XWalk (in)	N/A
			N/A	Any Obstruction?	N/A
				Obstruction Type	N/A
			N/A	Storm Grate/Utility Hazard?	N/A
				Storm Grate/Utility Type	N/A
			Yes	Surface Condition? (G/P)	Good
				Curb Slope (%)	11.9

Remove & Replace Entire Ramp.
