Access Compliance Report

Public Rights-of-Way

(Curb Ramps)

Intersection ID: 50941	Main Street: CANMORE_ST	Cross Street: CEDAR_WALK_LN	Location: SE
ADA ID: E51BEFFE6B20	Ramp Type: PerpDiag	Initial Pass/Fail: Fail	Overall Compliance: No
Severity Score: 46.25			
Codes/Mitigation Info/Possible Solution		Field Measurements/Component Compliance

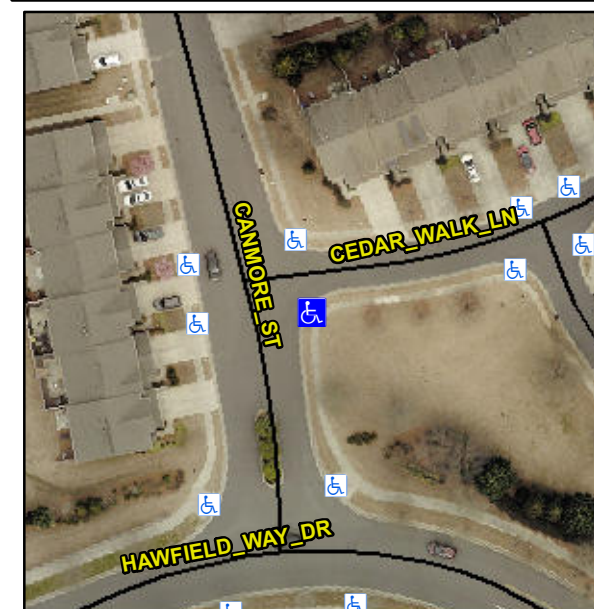
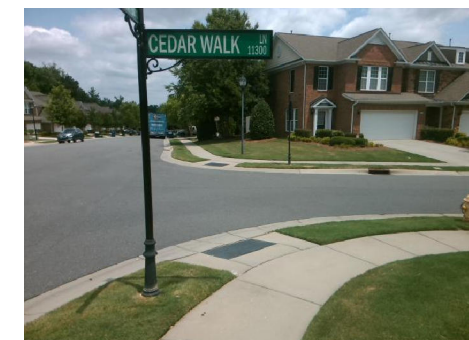
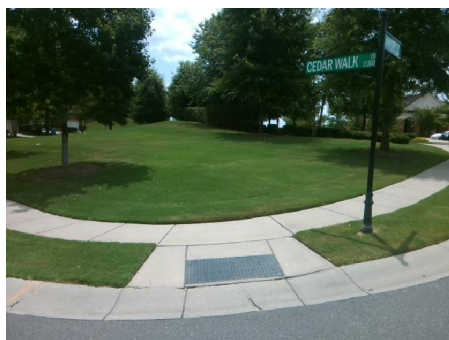
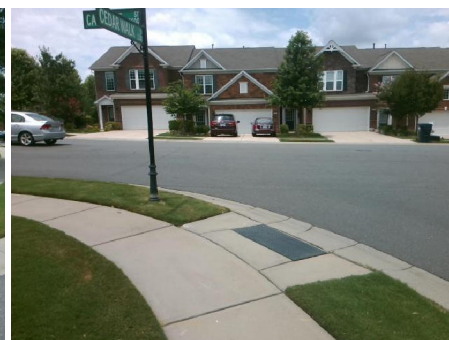
Not Found, R304.5.1, R304.2.2, R304.5.3

Compliance	Description	Data	Compliance	Description	Data
N/A	Ramp Length (in)	46.0	No	Ramp Slope (%)	9.7
No	Ramp Width (in)	47.0	No	Ramp XSlope (%)	8.5
N/A	Flare Type LT	N/A	N/A	Flare Type RT	N/A
N/A	Flare Slope LT (%)	N/A	N/A	Flare Slope RT (%)	N/A
N/A	Flare Traversable LT?	N/A	N/A	Flare Traversable RT?	N/A
N/A	Landing Length (in)	N/A	N/A	DWS Provided?	N/A
N/A	Landing Width (in)	N/A	N/A	DWS Contrast?	N/A
N/A	Landing Slope (%)	N/A	N/A	DWS Length (in)	N/A
N/A	Landing X Slope (%)	N/A	N/A	DWS Full Width?	N/A
N/A	Landing Curb? (Y/N)	N/A	N/A	DWS Offset (in)	N/A
N/A	Shared Landing?	N/A			
N/A	Gutter Ponding?	N/A	N/A	Gutter Slope (%)	N/A
N/A	Gutter Lip Ht (in)	N/A	N/A	Gutter X Slope (%)	N/A
N/A	Painted X Walk1?	No	N/A	Painted X Walk2?	No
	X Walk 1 Direction	To N		X Walk 2 Direction	To W
N/A	X Walk 1 Width (in)	N/A	N/A	X Walk 2 Width (in)	N/A
	X Walk 1 Slope (%)	1.1		X Walk 2 Slope (%)	4.8
	X Walk 1 X Slope (%)	4.6		X Walk 2 X Slope (%)	4.7

N/A	Ramp inside XWalk1?	N/A	N/A	Ramp inside XWalk2?	N/A
	Road Slope (%)	6.3	N/A	Clear Space?	N/A
	Road X Slope (%)	1.2	N/A	Clear Space to XWalk (in)	N/A
N/A	Any Obstructions?	N/A	N/A	Storm Grate/Utility Hazard?	N/A
	Obstruction Type			Storm Grate/Utility Type	
		N/A			N/A
			Yes	Surface Condition? (G/P)	Good

Remove & Replace Curb Ramp With Two New Directional Ramps or Equivalent.
