## Access Compliance Report Public Rights-of-Way (Curb Ramps)

Intersection ID: 10038458Main Street:SOUTHERN\_PINE\_BVCross Street:N/ALocation:NEADA ID: E56DFB05D666Ramp Type:PerpDiagInitial Pass/Fail:FailOverall Compliance:NoSeverity Score:58.75

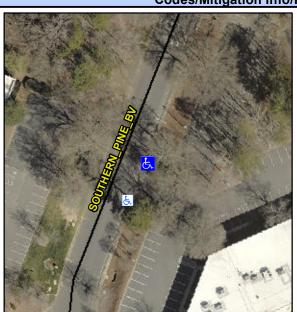
Not Found, R304.5.1, R304.2.2, R304.5.3

Field Measurements/Component Compliance					
Compliance Description		Data	Comp	liance Description	Data
N/A	Ramp Length (in)	44.0	No	Ramp Slope (%)	14.5
No	Ramp Width (in)	42.0	No	Ramp XSlope (%)	11.6
N/A	Flare Type LT	N/A	N/A	Flare Type RT	N/A
N/A	Flare Slope LT (%)	N/A	N/A	Flare Slope RT (%)	N/A
N/A	Flare Traversable LT?	N/A	N/A	Flare Traversable RT?	N/A
N/A	Landing Length (in)	N/A	N/A	DWS Provided?	N/A
N/A	Landing Width (in)	N/A	N/A	DWS Contrast?	N/A
N/A	Landing Slope (%)	N/A	N/A	DWS Length (in)	N/A
N/A	Landing X Slope (%)	N/A	N/A	DWS Full Width?	N/A
N/A	Landing Curb? (Y/N)	N/A	N/A	DWS Offset (in)	N/A
N/A	Shared Landing?	N/A			
N/A	Gutter Ponding?	N/A	N/A	Gutter Slope (%)	N/A
N/A	Gutter Lip Ht (in)	N/A	N/A	Gutter X Slope (%)	N/A
N/A	Painted X Walk1?	No	N/A	Painted X Walk2?	No
	X Walk 1 Direction	To W		X Walk 2 Direction	To S
N/A	X Walk 1 Width (in)	N/A	N/A	X Walk 2 Width (in)	N/A
	X Walk 1 Slope (%)	4.0		X Walk 2 Slope (%)	2.1

X Walk 1 X Slope (%)	0.1		X Walk 2 X Slope (%)	10.6
N/A	Ramp inside XWalk1?	N/A	N/A	Ramp inside XWalk2?	N/A
	Road Slope (%)	2.4	N/A	Clear Space?	N/A
	Road X Slope (%)	2.9	N/A	Clear Space to XWalk (in)	N/A
N/A	Any Obstructions?	N/A	N/A	Storm Grate/Utility Hazard?	N/A
	Obstruction Type			Storm Grate/Utility Type	
		N/A			N/A
			Yes	Surface Condition? (G/P)	Good

SOUTHERN PINE BV None ENTRANCE None Possible Solutions:

Remove & Replace Curb Ramp With Two New Directional Ramps or Equivalent.
