Access Compliance Report

Public Rights-of-Way

(Curb Ramps)

Intersection ID: 22977	Main Street: SOUTH_BV	Cross Street: MUSTANG_LN	Location: SE
ADA ID: E59EA0E4DC71	Ramp Type: Perp	Initial Pass/Fail: Fail	Overall Compliance: No
Severity Score: 21.25			
Codes/Mitigation Info/Possible Solution		Field Measurements/Component Compliance

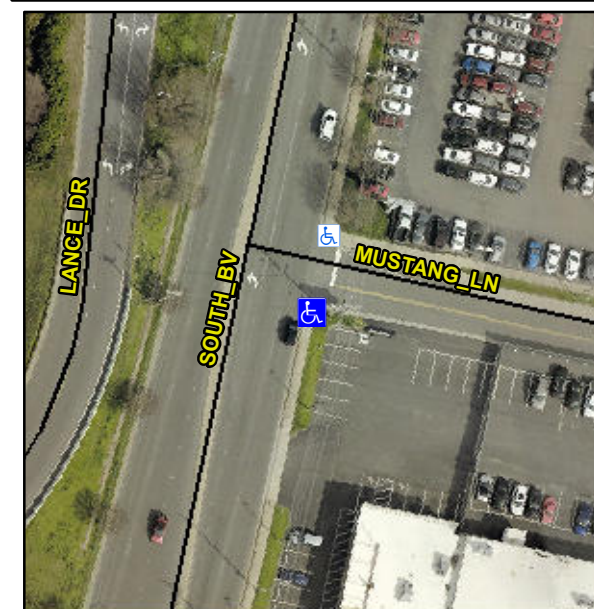
Not Found, R304.5.1, R304.5.3

Compliance	Description	Data	Compliance	Description	Data
N/A	Ramp Length (in)	60.0	Yes	Ramp Slope (%)	6.5
No	Ramp Width (in)	47.5	No	Ramp XSlope (%)	6.3
N/A	Flare Type LT	N/A	N/A	Flare Type RT	N/A
N/A	Flare Slope LT (%)	N/A	N/A	Flare Slope RT (%)	N/A
N/A	Flare Traversable LT?	N/A	N/A	Flare Traversable RT?	N/A
N/A	Landing Length (in)	N/A	N/A	DWS Provided?	N/A
N/A	Landing Width (in)	N/A	N/A	DWS Contrast?	N/A
N/A	Landing Slope (%)	N/A	N/A	DWS Length (in)	N/A
N/A	Landing X Slope (%)	N/A	N/A	DWS Full Width?	N/A
N/A	Landing Curb? (Y/N)	N/A	N/A	DWS Offset (in)	N/A
N/A	Shared Landing?	N/A			
N/A	Gutter Ponding?	N/A	N/A	Gutter Slope (%)	N/A
N/A	Gutter Lip Ht (in)	N/A	N/A	Gutter X Slope (%)	N/A
N/A	Painted X Walk1?	No	N/A	Painted X Walk2?	N/A
	X Walk 1 Direction	To N		X Walk 2 Direction	N/A
N/A	X Walk 1 Width (in)	N/A	N/A	X Walk 2 Width (in)	N/A
	X Walk 1 Slope (%)	0.6		X Walk 2 Slope (%)	N/A
	X Walk 1 X Slope (%)	1.4		X Walk 2 X Slope (%)	N/A

N/A	Ramp inside XWalk1?	N/A	N/A	Ramp inside XWalk2?	N/A
	Road Slope (%)	N/A	N/A	Clear Space?	N/A
	Road X Slope (%)	N/A	N/A	Clear Space to XWalk (in)	N/A
N/A	Any Obstructions?	N/A	N/A	Storm Grate/Utility Hazard?	N/A
	Obstruction Type			Storm Grate/Utility Type	
		N/A			N/A
			Yes	Surface Condition? (G/P)	Good

Remove & Replace Entire Ramp.
